## 9.12 GPR Data Show Location of Buried Debris and Piping Associated with a Former Gas Holder in Minnesota

Minnesota Pollution Control Agency

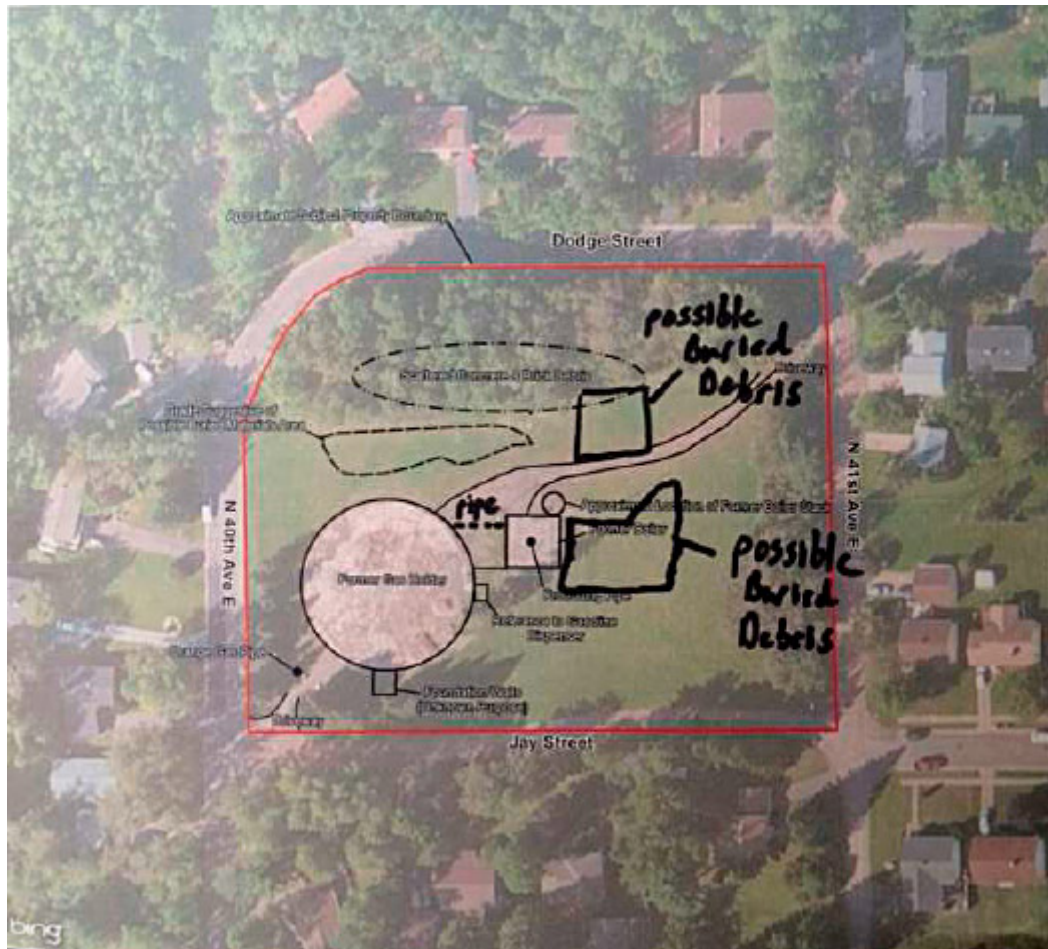
**Figure 9-43. GPR investigation area, as presented in report from contractor.**

Scans were collected with the GPR unit in parallel lines approximately 3 ft on center. The GPR unit was able to detect to approximately 4 ft below ground surface. The assessment revealed two locations with possible buried debris at depths of 2 ft to 4 ft below ground surface (see Figure 9-44 and Figure 9-45) near test pits TP-03 and TP-06 (see Figure 9-42 for test pit locations). The data images in Figure 9-45 for TP-06 were from scans performed just east of the former boiler room. The GPR equipment consistently picked up images of either fill material or disturbed soil in this area. The cost of this assessment was \$3,200.

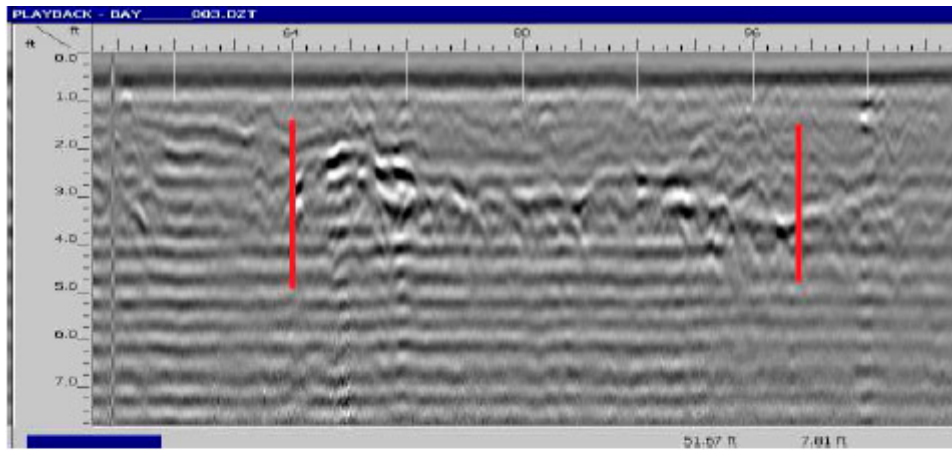
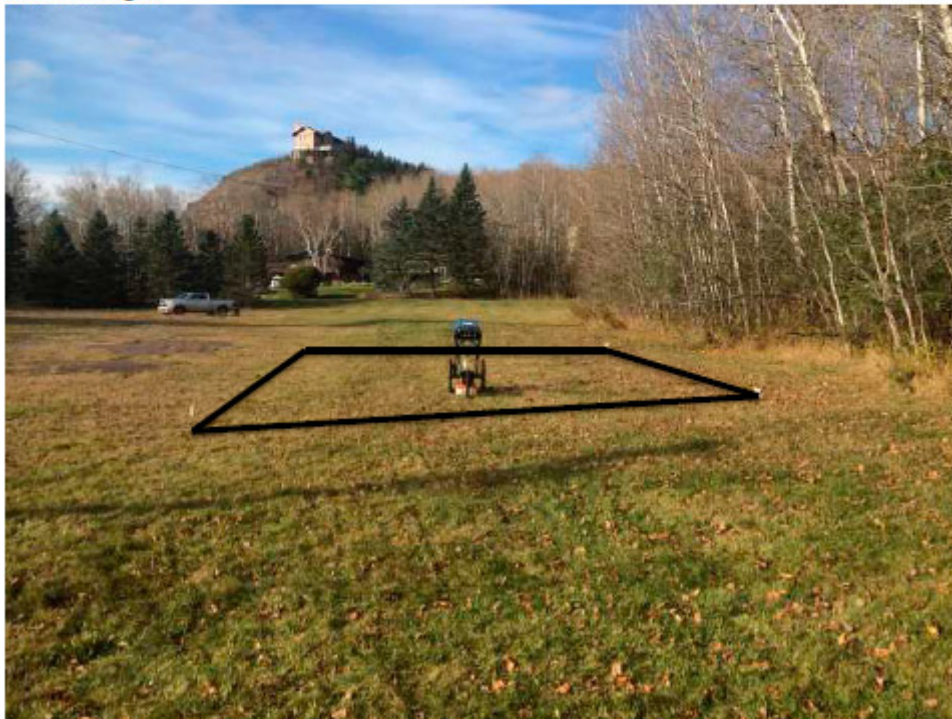
Figure 9-44. GPR scan and input from GPR contractor. Location pertains to TP-03.

This data image shows some possible buried debris at 2-4 feet deep. The next picture corresponds with this data image.

A subsequent test pit investigation was performed in January 2014 to confirm the findings of the GPR assessment (BayWest 2014). The investigation confirmed the presence of debris at TP-03 at a depth of 2 ft to 6 ft below ground surface. The GPR assessment also identified a pipe connecting the former gas holder to the former boiler at approximately 2 ft to 2.5 ft below ground surface (see Figure 9-46); its presence was confirmed at test pit TP-02 where it was encountered at approximately 2 ft below ground surface.
