9.17 Drone Technology Expedites and Streamlines Site Characterization at a Former Golf Course in Missouri

Ramboll US Corporation

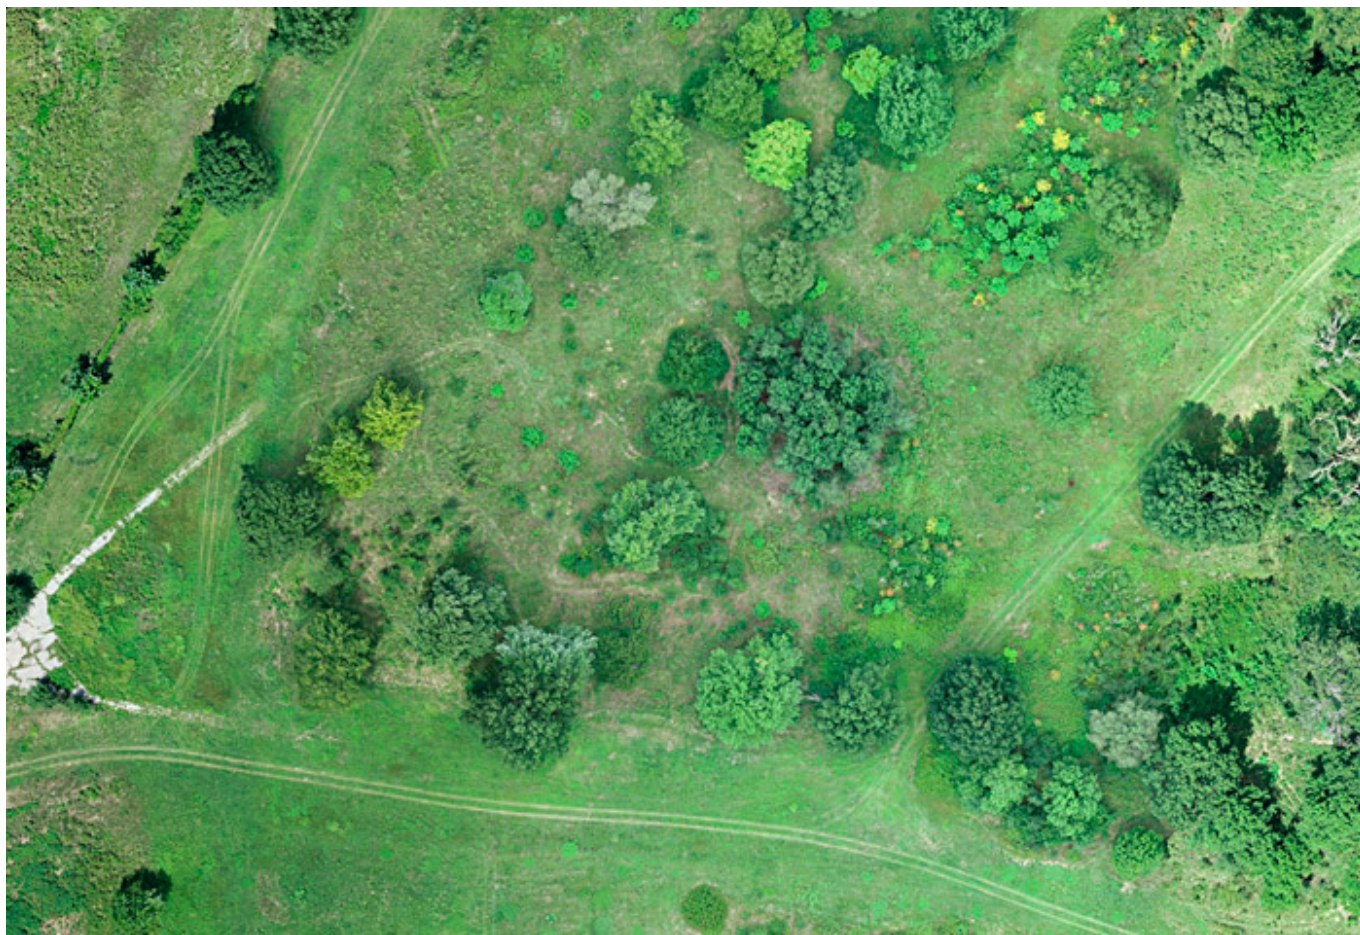
Figure 9-62. Pre-excavation site characterization of one area where soil removal was documented

Anecdotal information suggested that, as part of previous remediation efforts, the golf greens were scraped and the excavated soil was stockpiled on the northern portion of the site. To locate these potential stockpiles, a drone was used to collect visual images. The images were examined, and photogrammetric analysis revealed no elevated areas indicative of soil stockpiles or areas of obvious tone or texture differences indicative of soil disturbance. Additionally, high-resolution orthoimagery was integrated into mobile GIS to assist in confirming sample locations and their relative location to historic

course features (see Figure 9-62, Figure 9-63 and Figure 9-64 for example images).

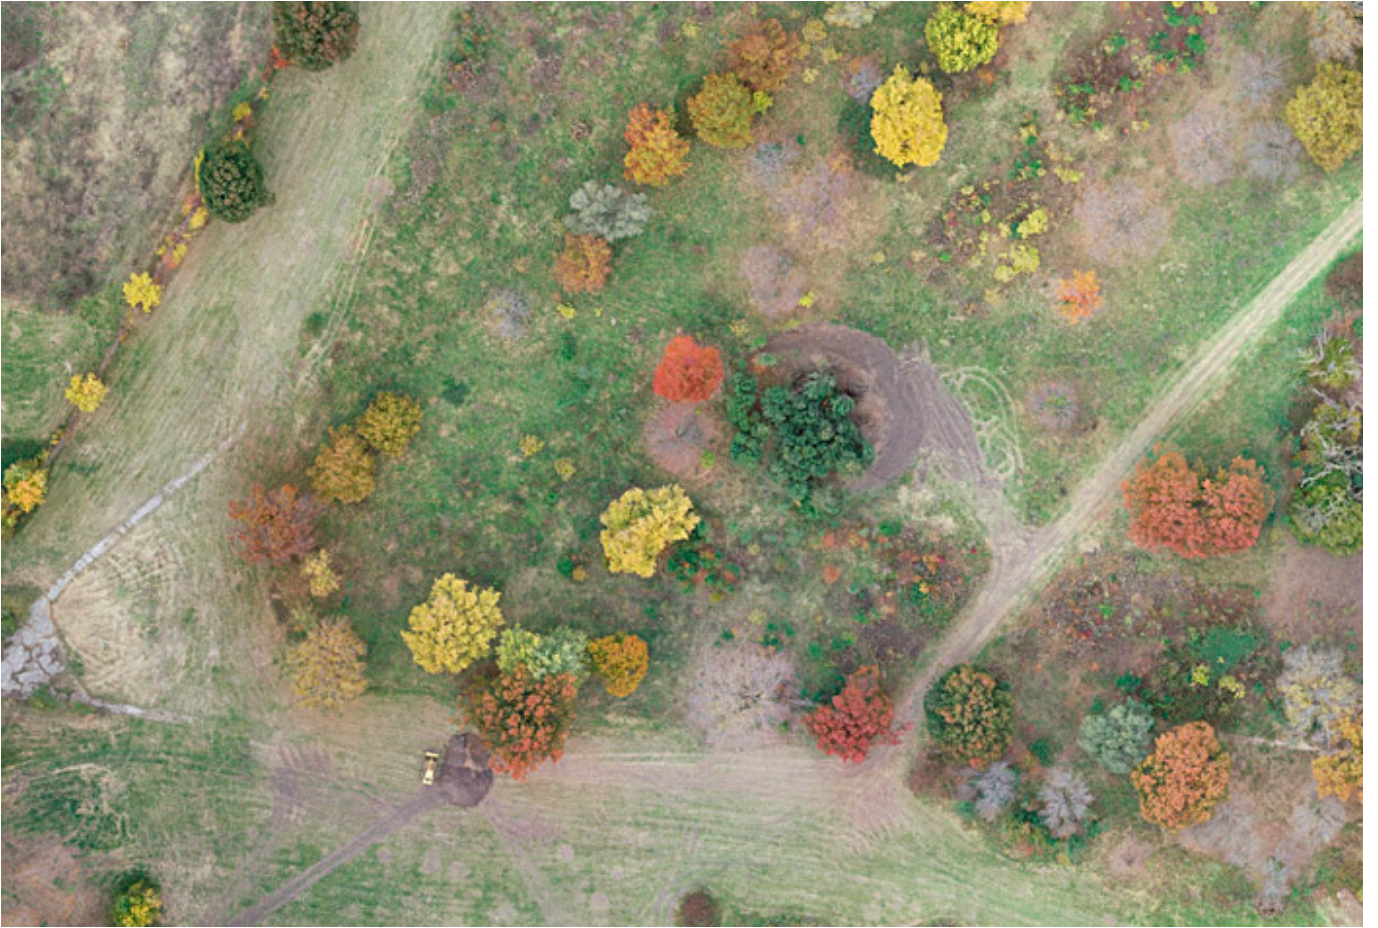
Figure 9-63. Postexcavation of one area with soil stockpile next to equipment

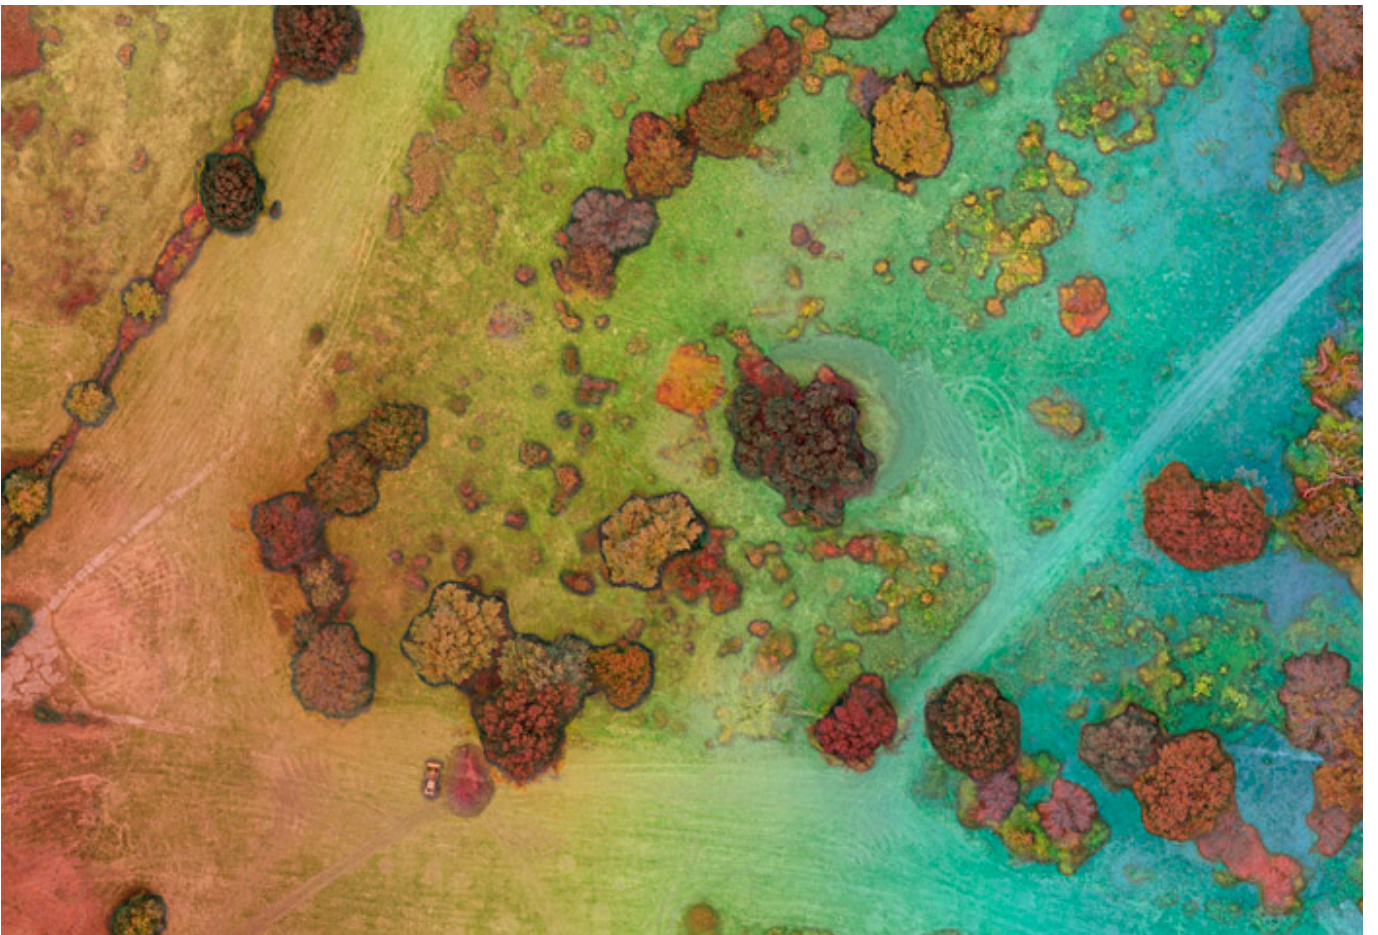
Figure 9-64. Postexcavation digital surface model with soil stockpile next to equipment

The processed orthomosaic imagery was brought into a web-based/mobile GIS platform (ArcGIS Online) using a Web Tile Layer created by DroneDeploy to allow the imagery to be viewed on an iPad Pro with a Bluetooth connection to a Trimble R1 global navigation satellite system (GNSS) receiver. This setup supports submeter location accuracy for the sample points directed by the imagery data. Field teams collected soil samples informed by the drone data, which were provided as a mobile GIS map. The collected samples were used to inform and direct excavation. Postexcavation, a second imagery dataset was captured. The combined dataset supported a GIS presentation of the site postexcavation. A replicate drone survey was performed following the excavation activities. The soil from the excavations was consolidated into four stockpiles for ease of loading for disposal. DroneDeploy was used to estimate the volume of the soil stockpiles and to denote the locations of excavation areas apparent on orthoimagery. The volume of the four stockpiles was estimated at approximately 301 cubic yards.
