## 9.17 Drone Technology Expedites and Streamlines Site Characterization at a Former Golf Course in Missouri

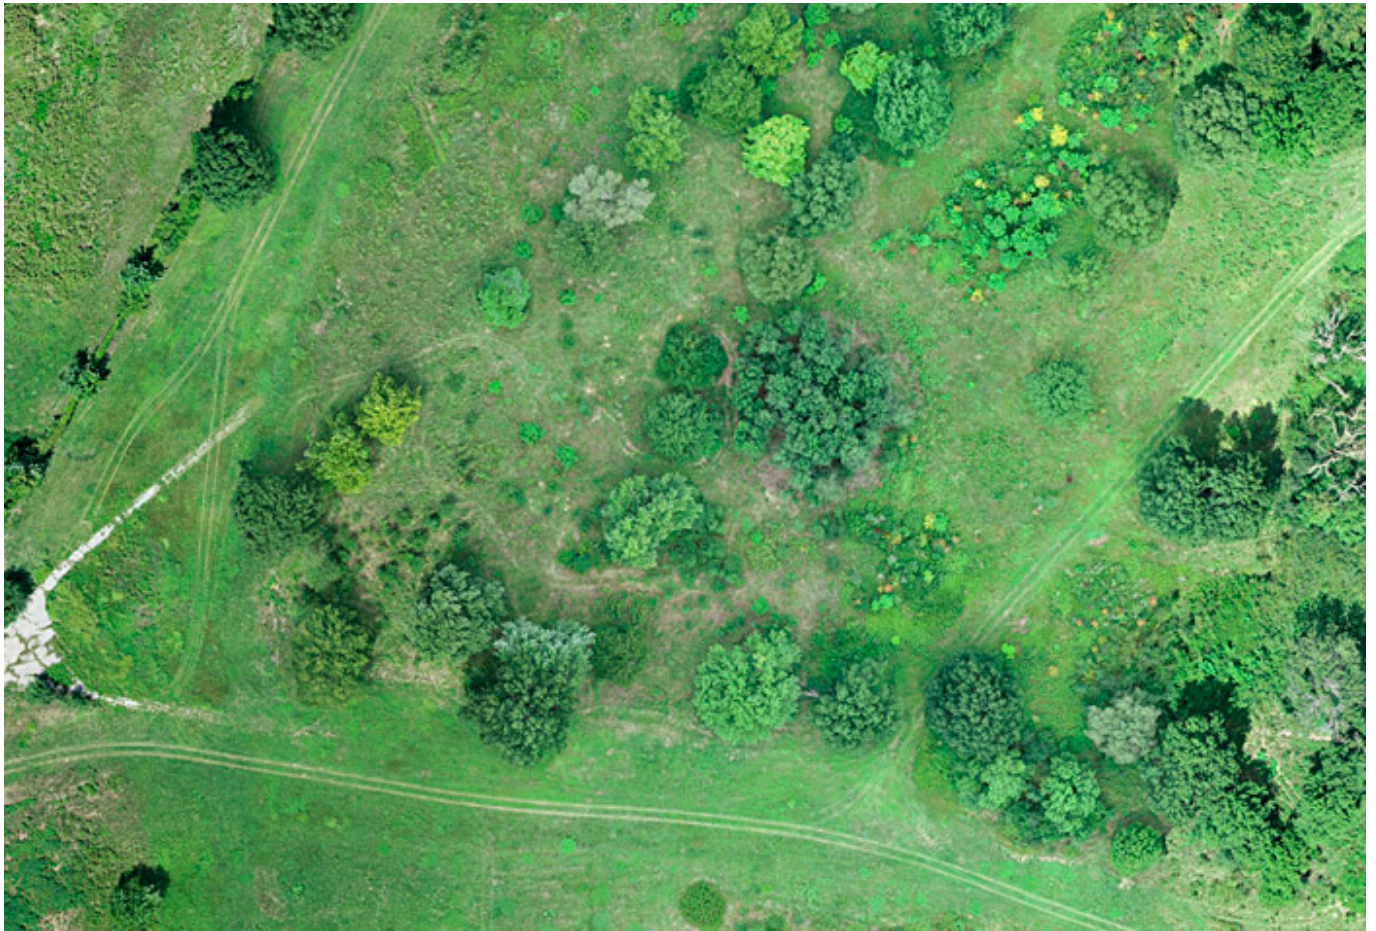
**Figure 9-62. Pre-excavation site characterization of one area where soil removal was documented**

Anecdotal information suggested that, as part of previous remediation efforts, the golf greens were scraped and the excavated soil was stockpiled on the northern portion of the site. To locate these potential stockpiles, a drone was used to collect visual images. The images were examined, and photogrammetric analysis revealed no elevated areas indicative of soil stockpiles or areas of obvious tone or texture differences indicative of soil disturbance. Additionally, high-resolution orthoimagery was integrated into mobile GIS to assist in confirming sample locations and their relative location to historic

course features (see Figure 9-62, Figure 9-63 and Figure 9-64 for example images).

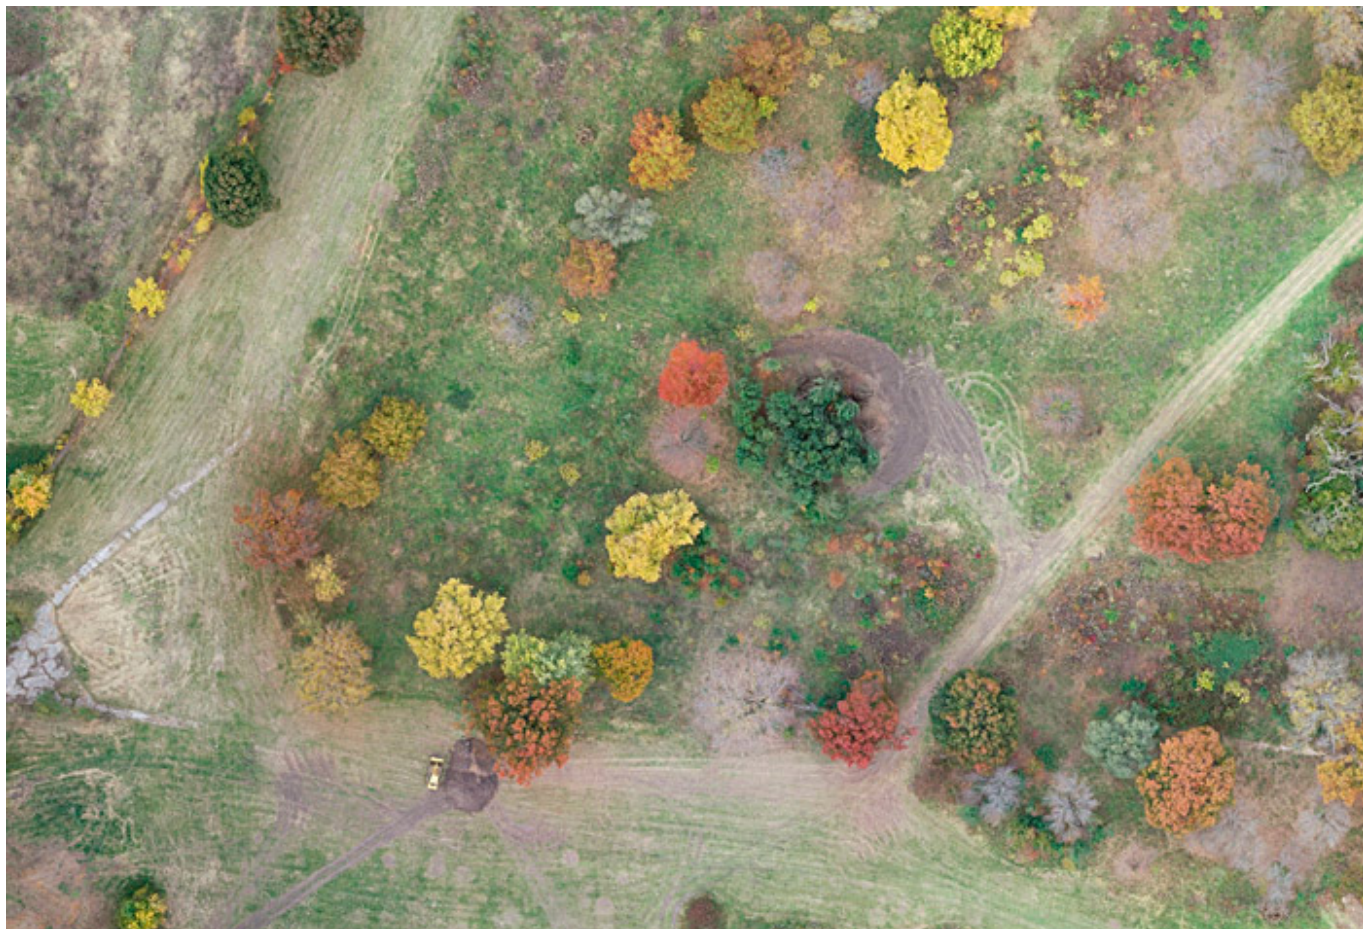
**Figure 9-63. Postexcavation of one area with soil stockpile next to equipment**
