9.18 High-Resolution and Thermal Aerial Images Identify Mine Openings at an Abandoned Colorado Mine

Ramboll US Corporation

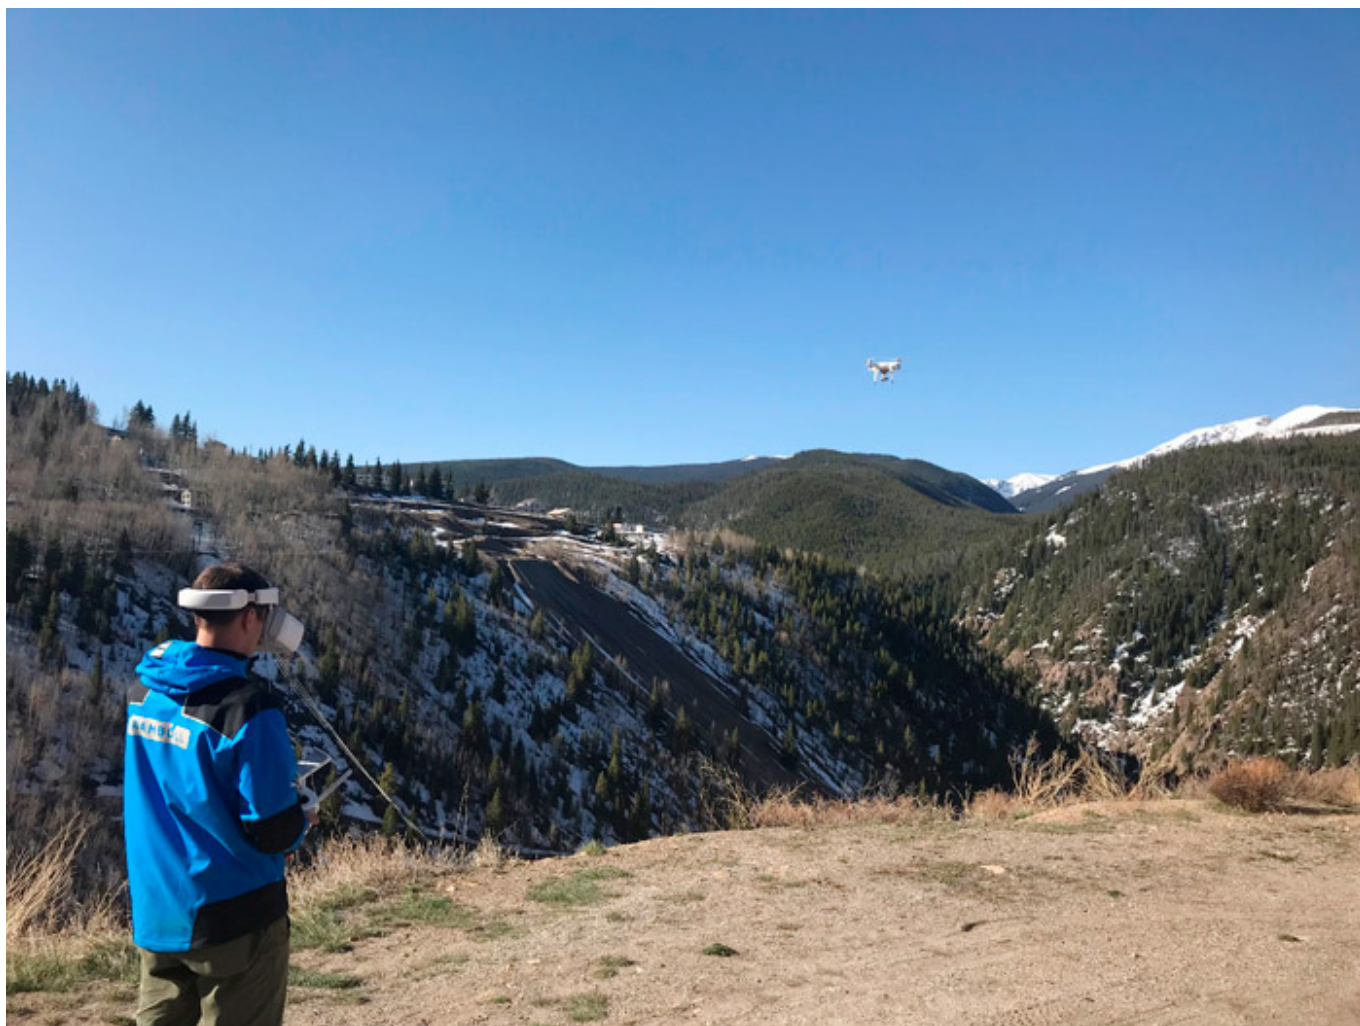
Figure 9-65. Remotely piloted aircraft system (RPAS) being piloted with DJI Goggles.

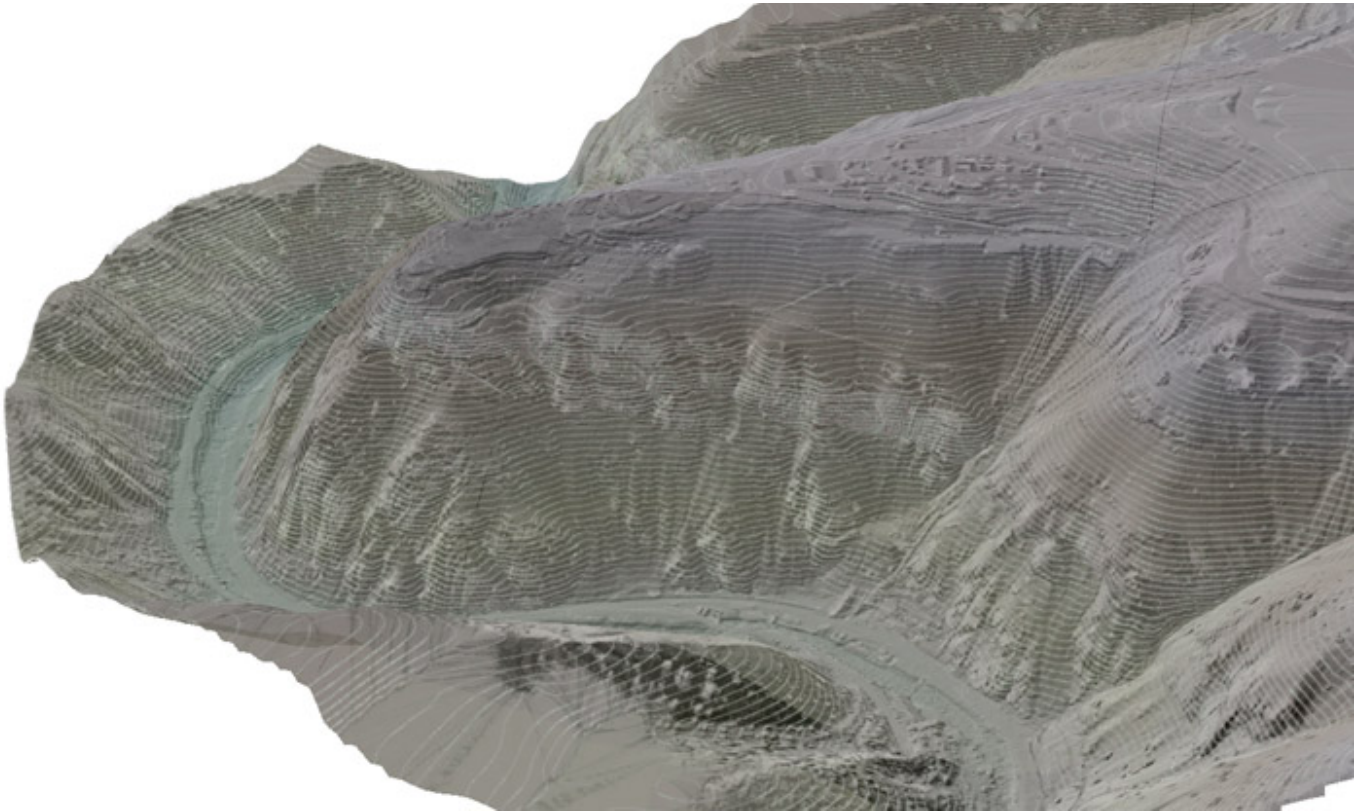
Figure 9-66. Digital surface model projected in three-dimensional visualization with 10-foot contour lines.

Multiple flights occurred over more than 450 acres during a five-day period between April 23 and April 27, 2018. Historic maps and reports were digitized and used for flight data collection planning. During flight, a series of geolocated infrared and visible spectrum images were captured for each mine feature documented in the inventory as well as for previously unidentified potential mine features based on thermal and visible anomalies. In total, more than 1,500 individual thermal images and 2,000 individual visible spectrum images were captured. These images were processed using DroneDeploy and Drone2Map to create two high-resolution composite images: one for the thermal spectrum and one for the visible spectrum. Additionally, these images were used to create a 3-D model and a digital surface model (DSM). To produce a DSM, vegetation and buildings were removed and replaced with an interpolated surface (see Figure 9-66).

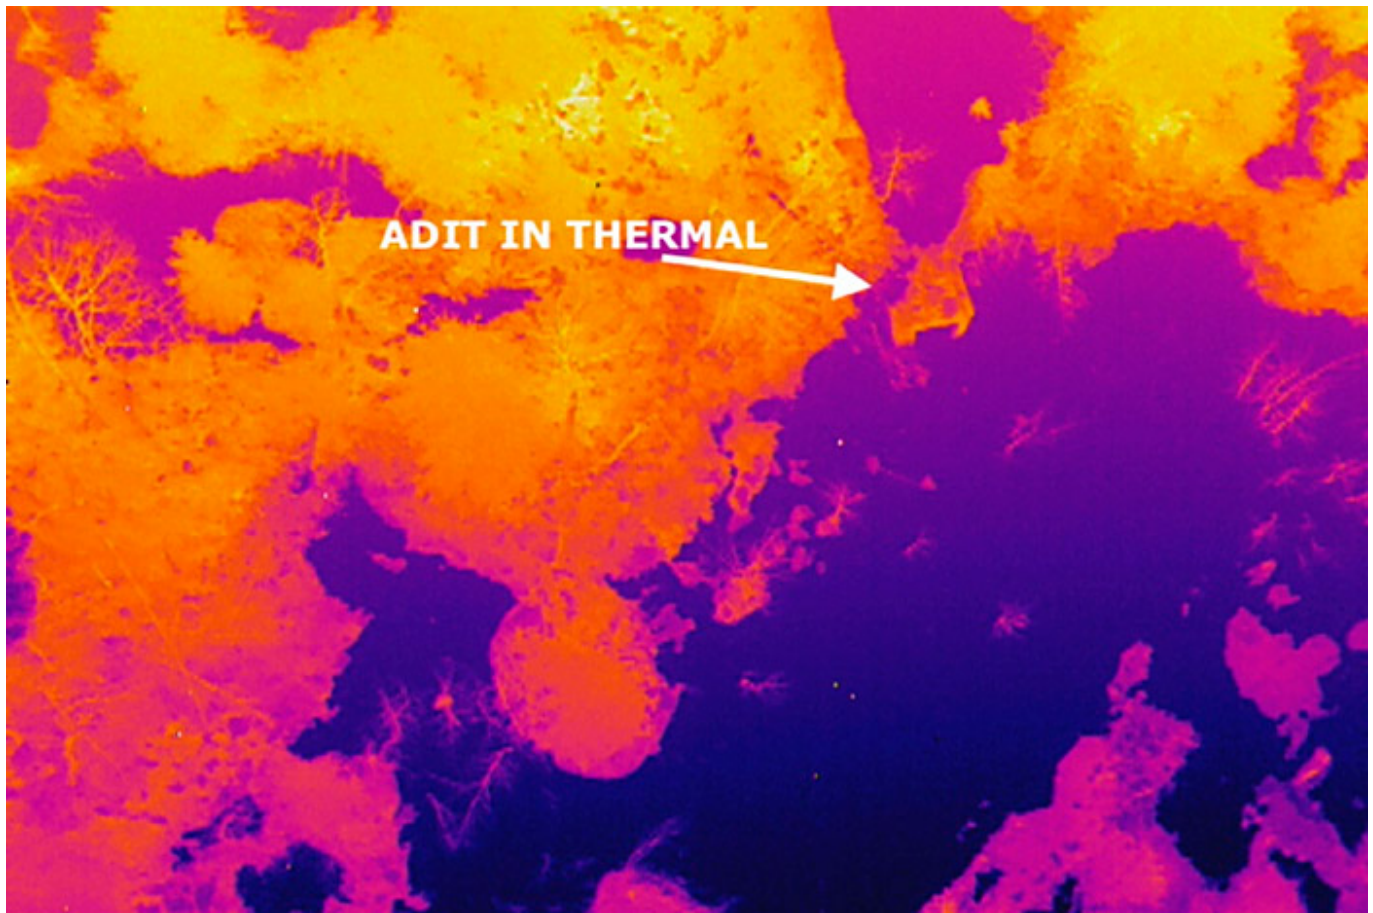
Figure 9-67. Adit identified in thermal imagery.

The processed orthomosaic imagery was brought into a web-based/mobile GIS platform (ArcGIS Online) using a Web Tile Layer created by DroneDeploy (see Figure 9-67). The unprocessed geolocated images were also brought into GIS and provided as a final data product. Therefore, field teams working at the site could view all imagery to be viewed on mobile GIS equipment (an iPad Pro with a Bluetooth connection to a Trimble R1 GNSS receiver). The integration of this digital data continues as part of site management and is available to support remedial efforts and facilitate optimization of actions in support of remediation.

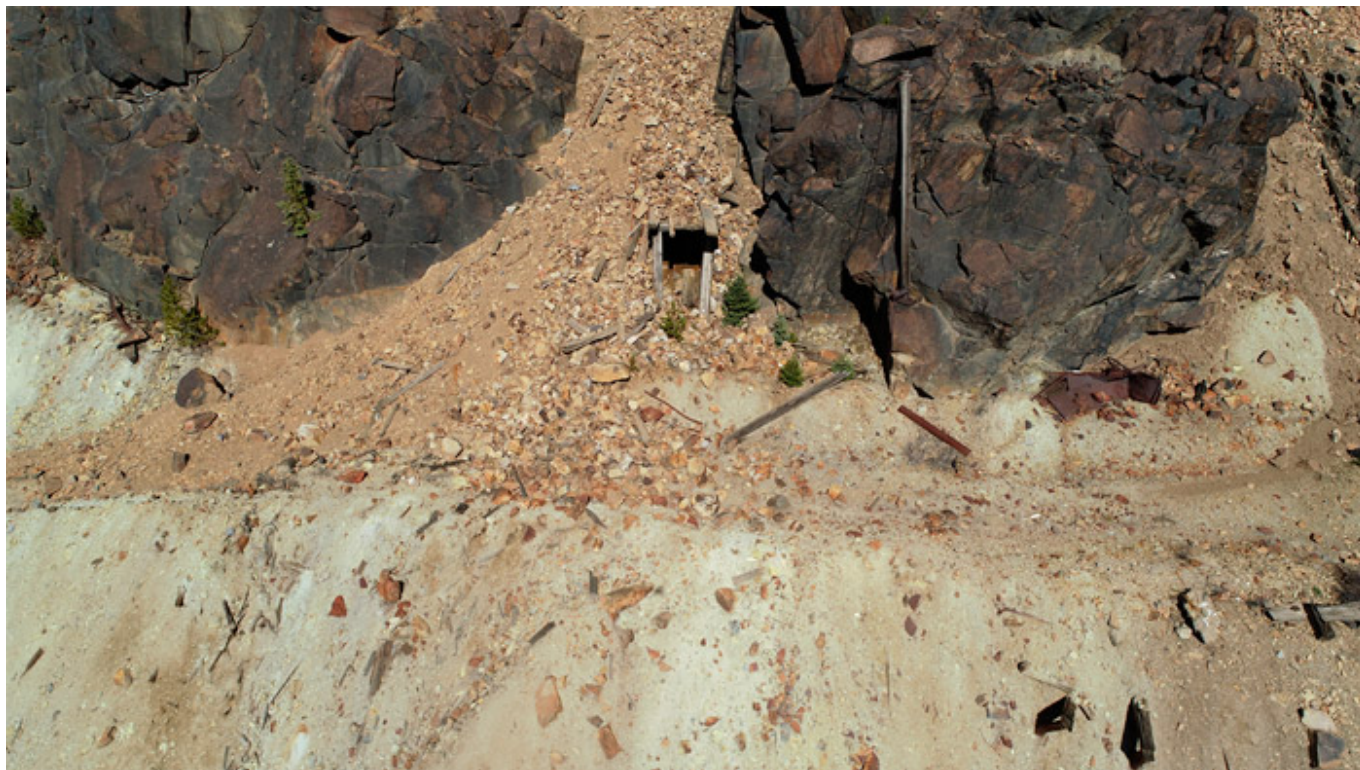
Figure 9-68. Mine opening only visible from oblique imagery.
