Printed from: Interstate Technology & Regulatory Council (ITRC). 2019. *Implementing Advanced Site Characterization Tools*. ASCT-1. Washington, D.C.: Interstate Technology & Regulatory Council, Advanced Site Characterization Tools Team. <https://asct-1.itrcweb.org>.

9.6 TarGOST Determines DNAPL Extent and HPT Confirms Site Lithology at a Former Creosote Facility in Louisiana

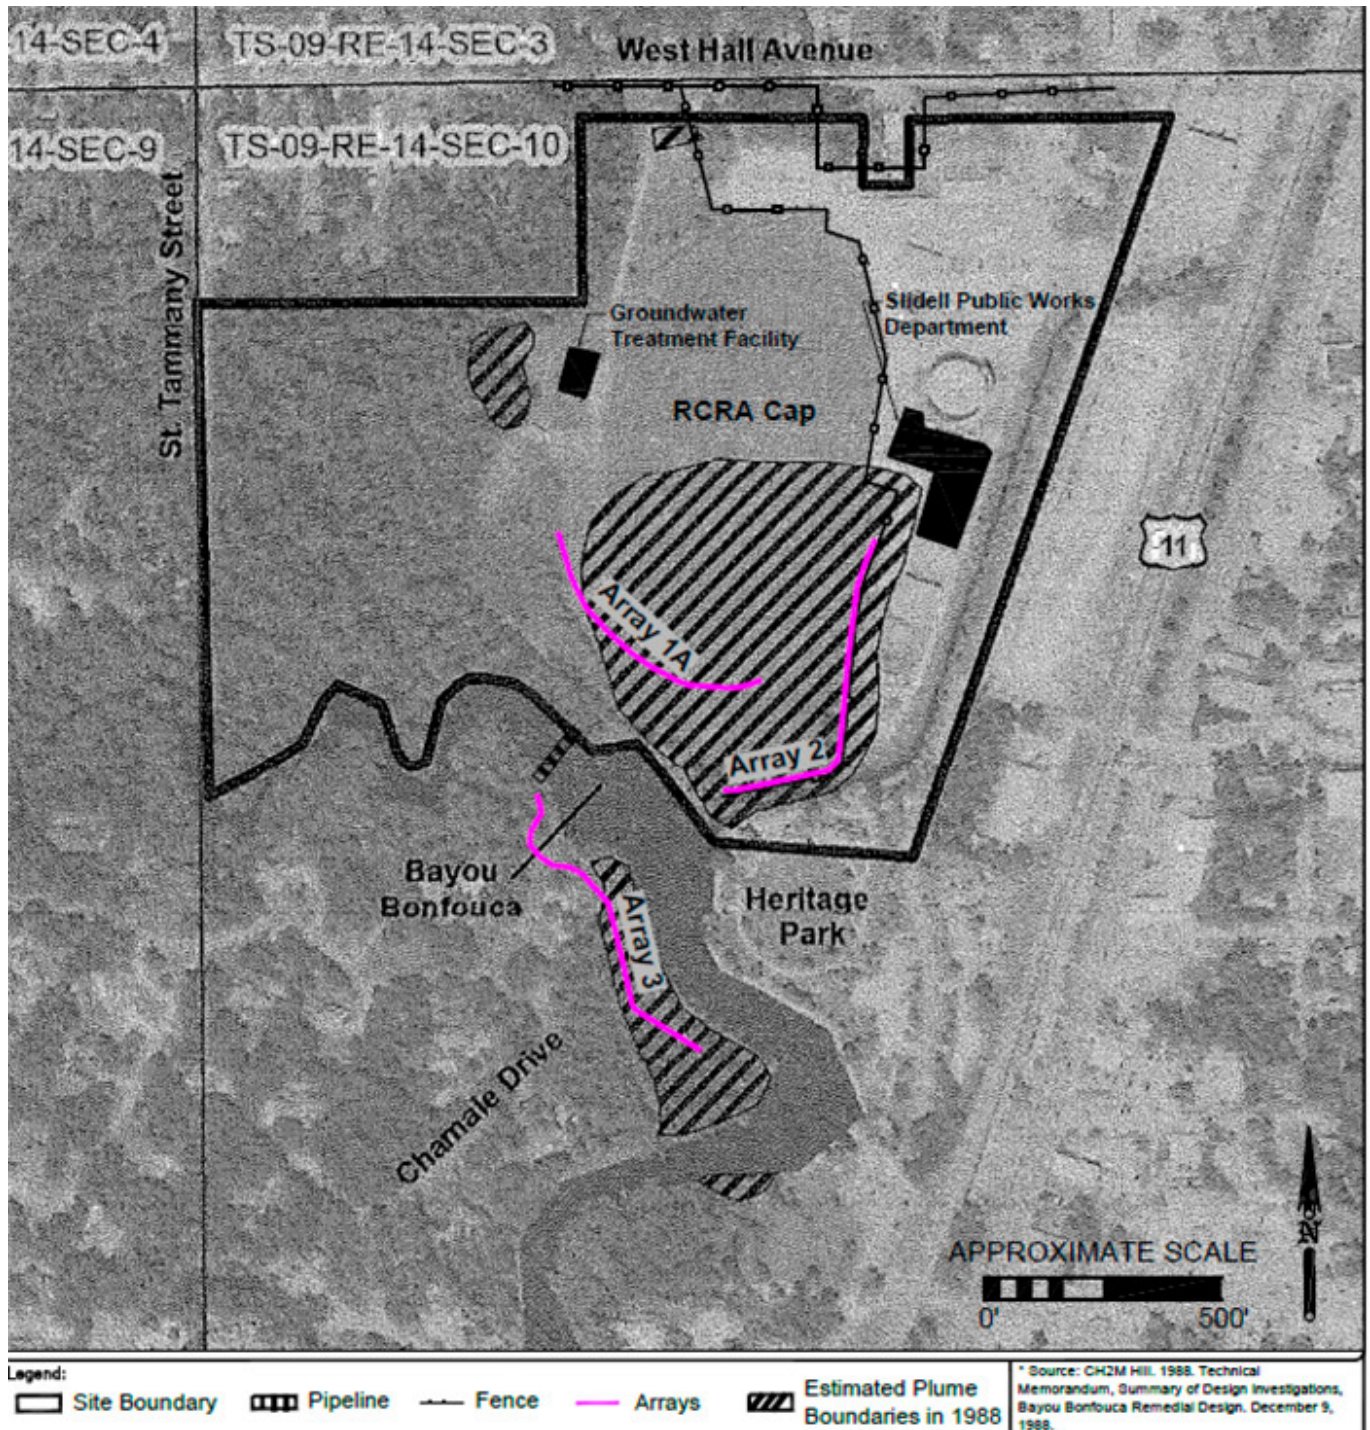
Figure 9-27. 1988 DNAPL plume and site features.

The groundwater treatment system continues to operate at the facility. The system recovers groundwater from two on-site recovery well arrays (arrays 1a and 2) and one off-site array (array 3) located on the opposite bank of the bayou. Approximately 100 gallons of DNAPL are recovered every month from the treatment system, and DNAPL has been observed in recovery wells in all three arrays (see Figure 9-27).

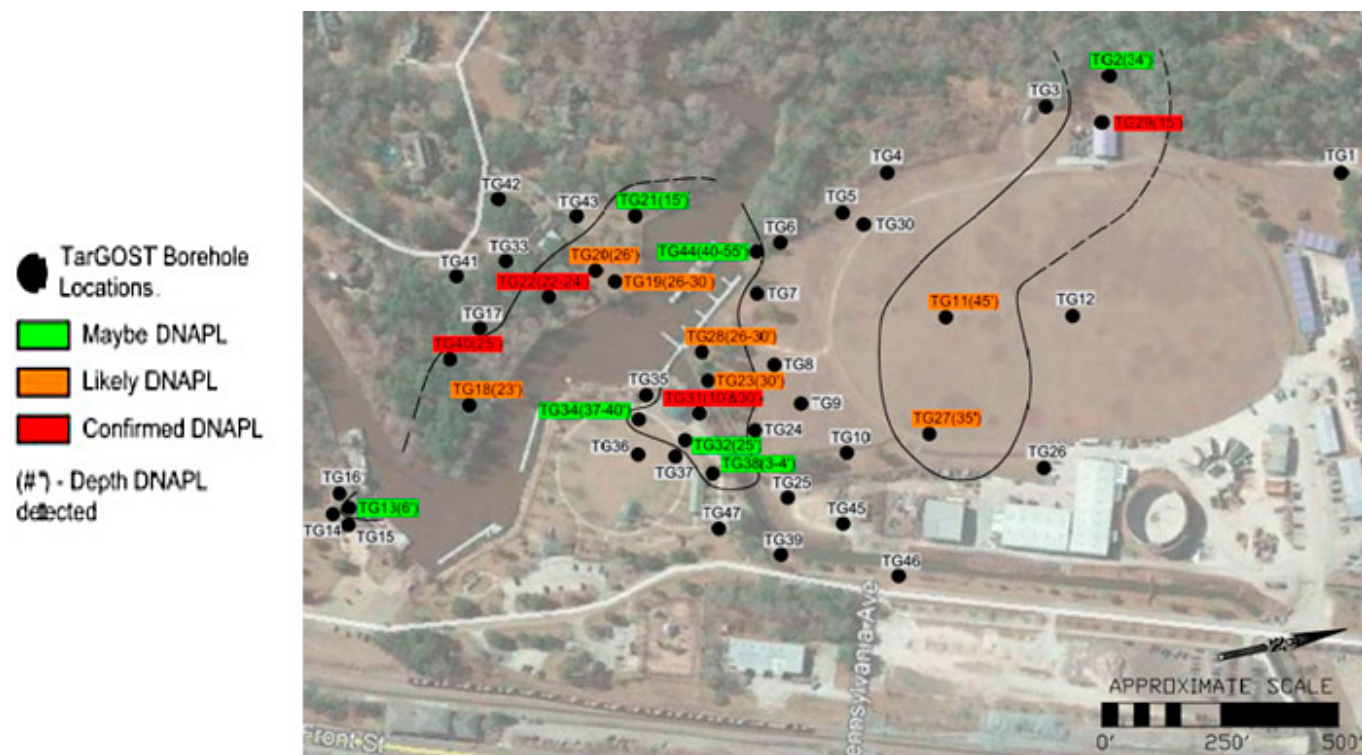
Figure 9-28. 2018 TarGOST sample locations and current plume interpretation.

Prior to field work, the fluorescence response of a sample of recovered creosote was measured via TarGOST. The resulting response was high, indicating that TarGOST would readily detect the NAPL *in situ*. The field survey was initiated in March 2018. Screening was conducted using the TarGOST within the footprint of the DNAPL plume as estimated in 1988. Thirty-three locations were screened during five days in March and April 2018. An additional 14 locations were screened during four days in November 2018 (see Figure 9-28). The maximum screening depth was 55 ft below ground surface, coinciding with a clayey cohesive unit into which the creosote has not historically penetrated. Confirmation soil and groundwater sampling, as well as soil logging, were conducted at approximately 25% of the screening locations to confirm the TarGOST observations and identify contaminants within the creosote plume.

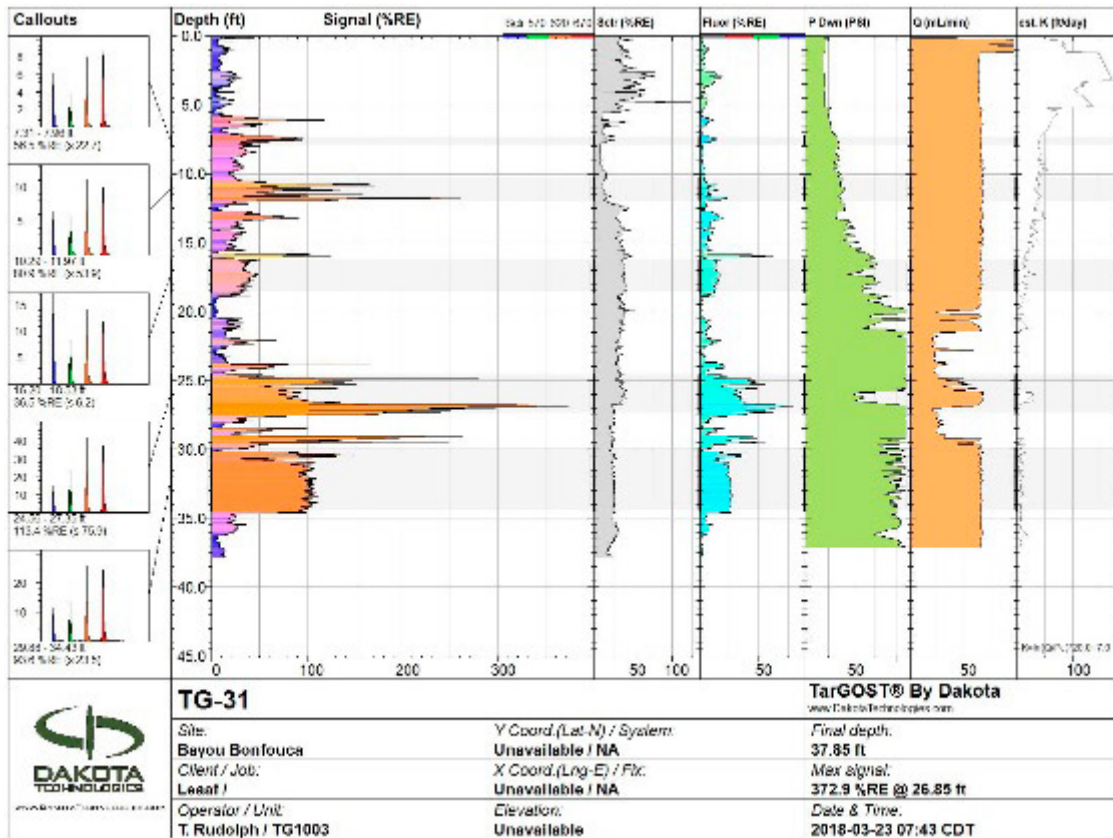
Figure 9-29. TarGOST and HPT log showing creosote fluorescence and water pressure responses.

While the DNAPL plume has not been fully delineated, the TarGOST defined the extent and relative amount of DNAPL present at sampled locations both on and off site (see Figure 9-29). This information will be used when evaluating the effectiveness of the current remedy. The HPT confirmed the site lithology that was described in the 1980s and 1990s.

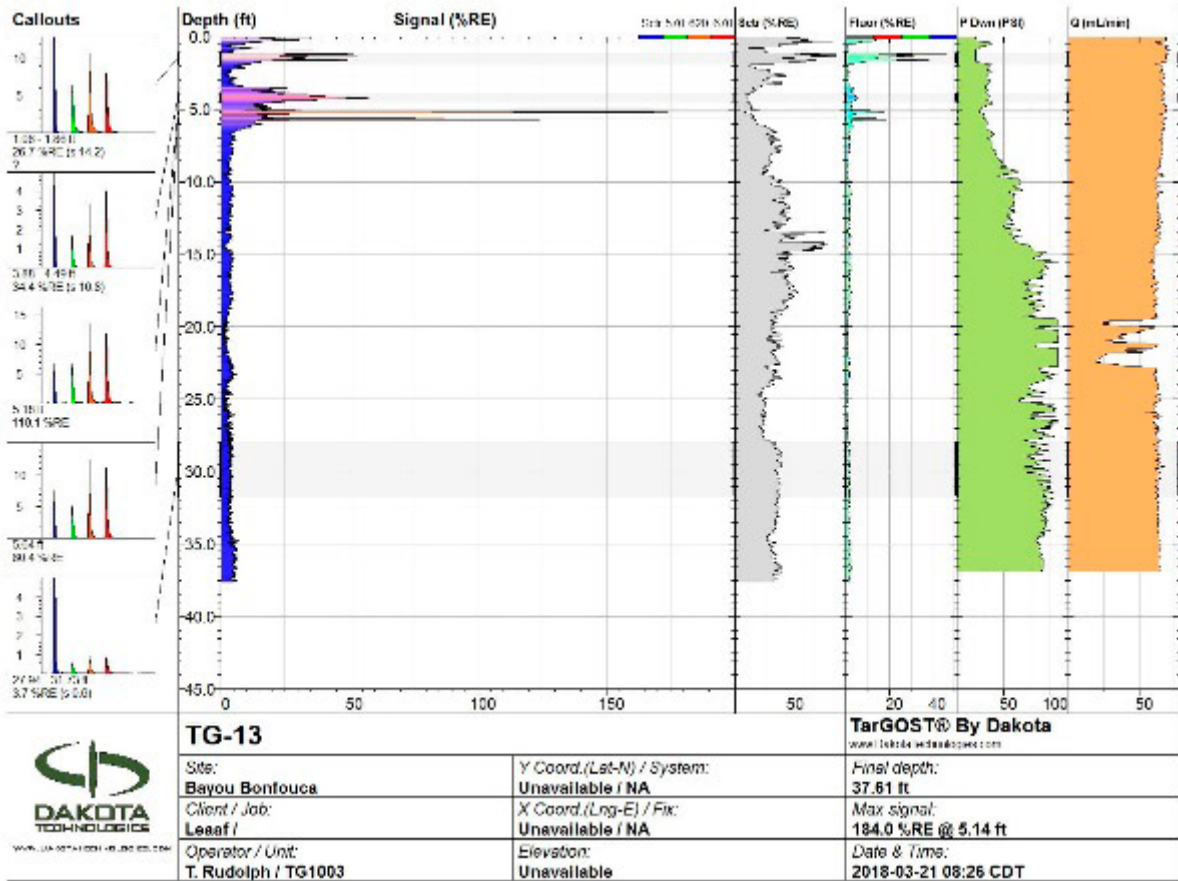
Figure 9-30. TarGOST and HPT log showing organic clay fluorescence near the surface.

Natural organic material can and does fluoresce similarly, but not identically, to creosote, and this occurred to some extent at this site. Organic clay, which exhibited high fluorescence, was observed in confirmation samples at one location. Roots and organic debris, which exhibited variable fluorescence, were observed in confirmation samples at several locations (see Figure 9-30 and Figure 9-31). The time-resolved fluorescence waveforms generated by the TarGOST, along with advanced analysis of these waveforms such as cluster diagrams, played a key role in discerning between the target DNAPL and organic matter. Confirmation sampling was essential to eliminate false interpretation of organic matter fluorescence. For each log with a response that was not confirmed with a soil boring, a determination as to whether DNAPL was “maybe present” or “likely present” was made based on the degree to which the unconfirmed logs were similar to the logs for confirmed DNAPL.

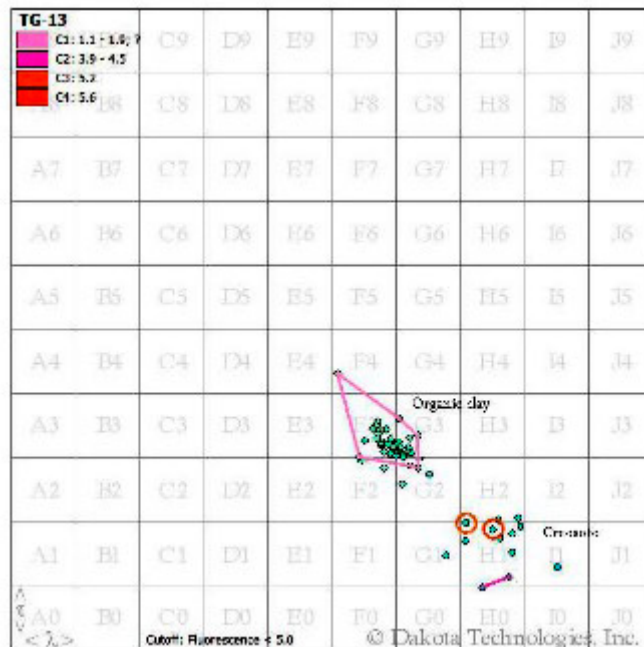
Figure 9-31. Wavelength scatter for organic clay and creosote.
