Printed from: Interstate Technology & Regulatory Council (ITRC). 2019. *Implementing Advanced Site Characterization Tools*. ASCT-1. Washington, D.C.: Interstate Technology & Regulatory Council, Advanced Site Characterization Tools Team. https://asct-1.itrcweb.org.

9.10 ERI Provides Data to Improve Groundwater Flow and Contaminant Transport Models at Hanford 300 Facility in Washington

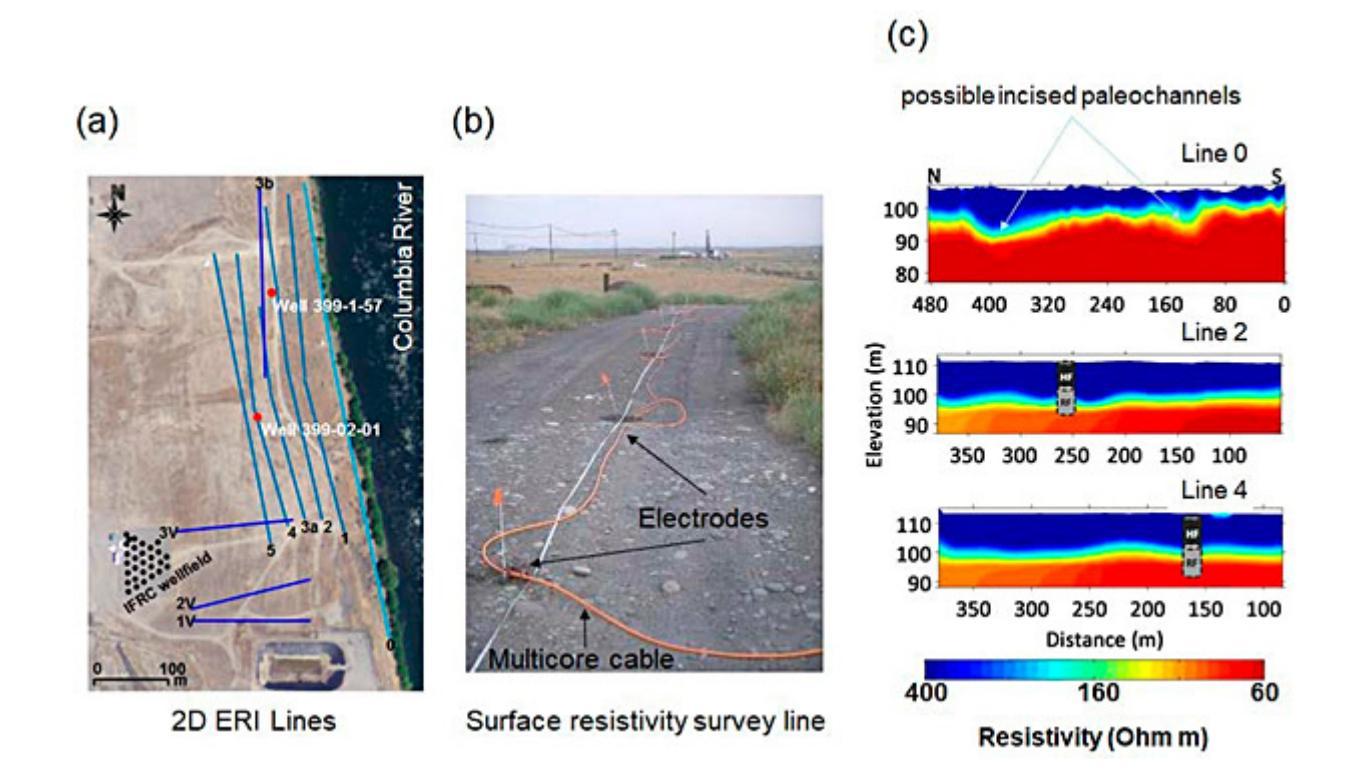
Figure 9-38. ERI survey at the DOE Hanford 300 Area, Richland, WA: (a) 2-D ERI survey line locations, (b) example of line showing site conditions and multicore cable/electrodes, (c) example 2-D images for three of the 10 lines showing strong electrical contrast between Hanford Formation (HF) and Ringold Formation (RF), with location of two boreholes with simplified log shown.

Two-dimensional resistivity surveying was performed to investigate variations in the depth to the Hanford-Ringold contact across the site and identify evidence for incisions in the Ringold Formation that might represent paleochannels (see Figure 9-38). The rationale for applying ERI was the expected strong contrast in electrical resistivity between the coarse-grained Hanford sediment (more resistive) and the fine-grained Ringold sediment (less resistive). A series of parallel, 2-D ERI lines was acquired on 400- to 500-m-long lines using a 5- and 10-m electrode spacing (see Figure 9-38a). Challenges faced in deploying these lines included steep terrain and high contact resistances due to dry soil. The latter was overcome by watering electrodes with a high-salinity solution.

The resulting images of an approximately 40-m investigation depth clearly defined the Hanford-Ringold contact and identified locations close to the river where the resistivity structure suggests the presence of paleochannels (see Figure 9-38c). An interpolated plan view showing the elevation of the sharp contrast in electrical resistivity representing the Hanford-Ringold contact (constructed using the 10 2-D transects shown in Figure 9-38) is presented in Figure 9-38. This figure also highlights (1) the path of a key paleochannel that coincides with the location of temperature anomalies from distributed temperature sensing (DTS) indicative of pronounced groundwater-surface water exchange, and (2) high uranium concentrations sampled in the river sediment. The DTS was performed using a fiber-optic DTS line placed along the river bed; temperature is inferred by scattering light transmitted along the cable. Uranium contours are based on concentrations measured in the boreholes (see Figure 9-39) across the site.

The 2-D assumption used in the inversion of the ERI dataset is reasonable for the lines parallel to the river, as evident by the strong similarity in structure between these lines. Simplified logs from two boreholes that were drilled at the site confirm that the imaged depth to the Hanford-Ringold contact is reasonable, given the inherent smoothing and limited resolution of the technology at depth. The results of this survey have been used to improve groundwater flow and contaminant transport models at the site.

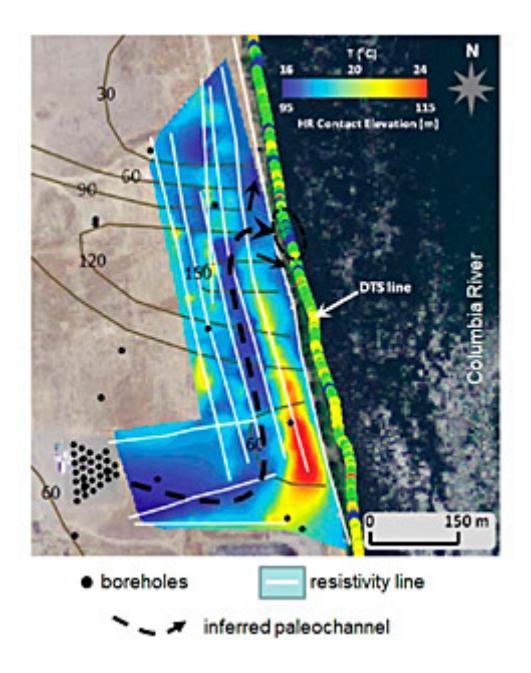
Figure 9-39. Elevation of Hanford-Ringold contact compared to temperature anomalies (from distributed temperature sensing [DTS]) showing [1] groundwater-surface water exchange locations, and [2] contours of uranium concentrations (mg/L) in aquifer from boreholes.
