Printed from: Interstate Technology & Regulatory Council (ITRC). 2019. *Implementing Advanced Site Characterization Tools*. ASCT-1. Washington, D.C.: Interstate Technology & Regulatory Council, Advanced Site Characterization Tools Team. https://asct-1.itrcweb.org.

### 9.13 Resistivity, Seismic Exploration, and GPR Provide Data to Evaluate Clay Reserves at a Commercially Mined Pit

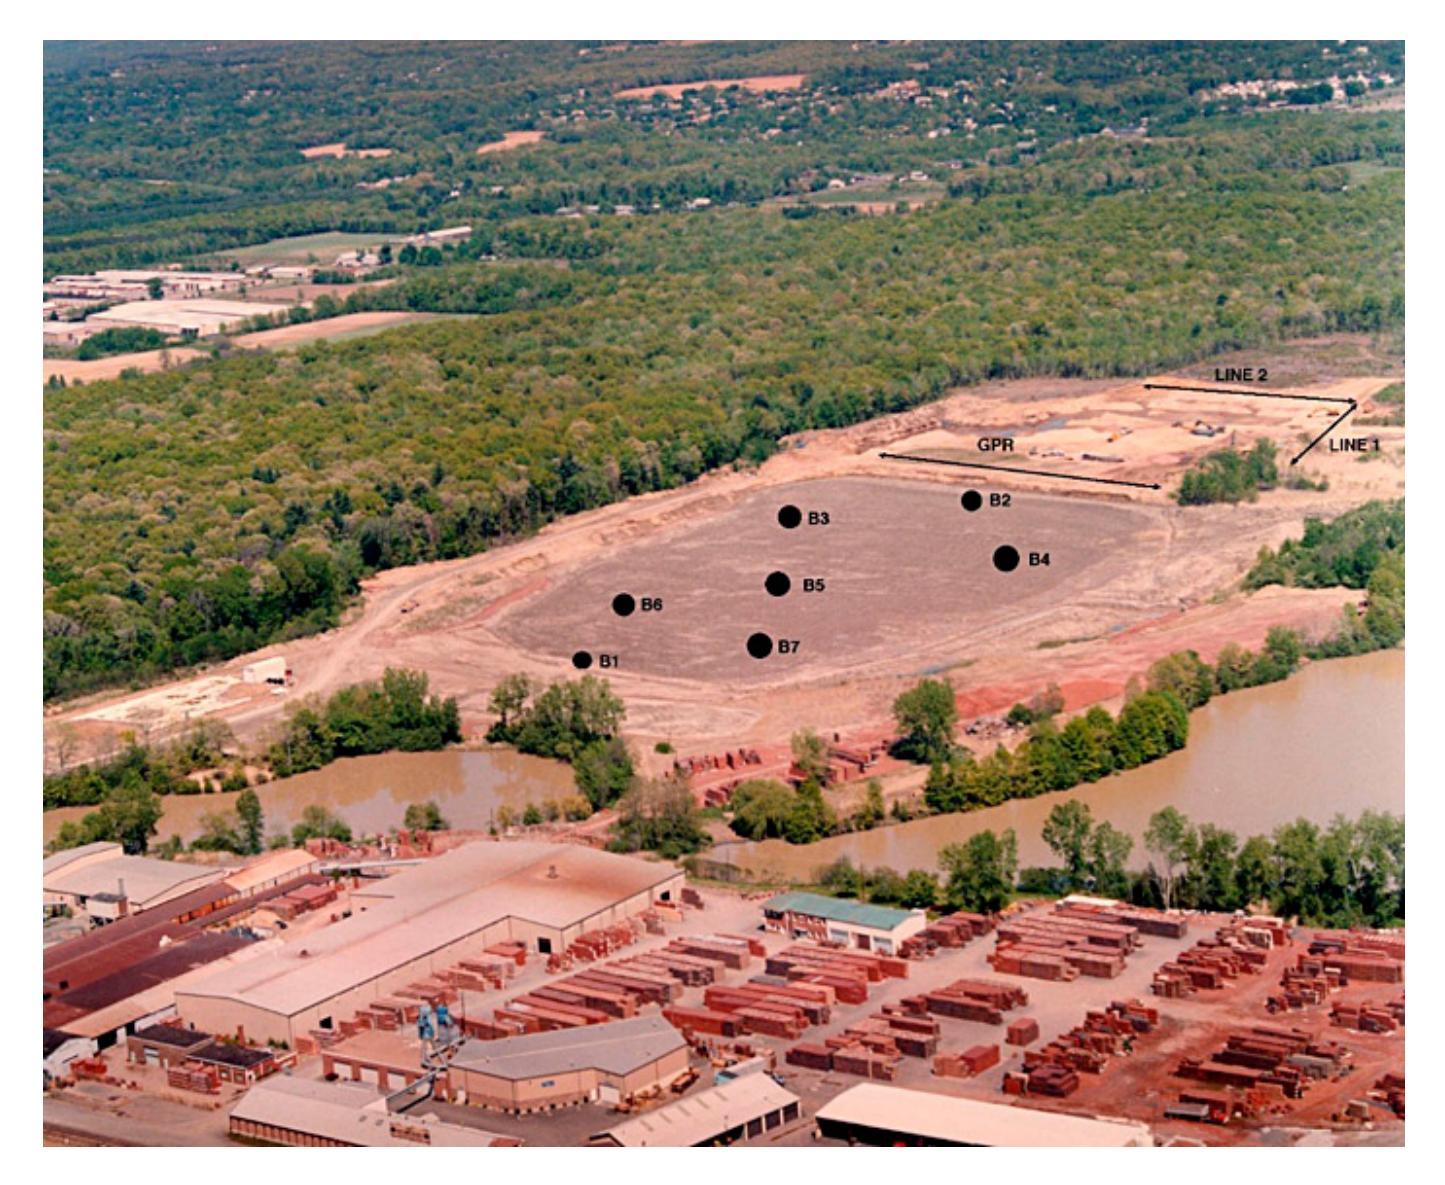
Figure 9-47. Aerial photo showing the approximate location where the geophysical surveys were performed.

Figure 9-47 is an aerial photo that shows where the geophysical surveys were performed. Line 1 (150 m) was the west-east line profile where DC-resistivity and seismic exploration were performed. Line 2 (150 m) was the south-north line profile for DC-resistivity and seismic exploration surveys. The GPR profile was performed along the arrow marked as GPR.

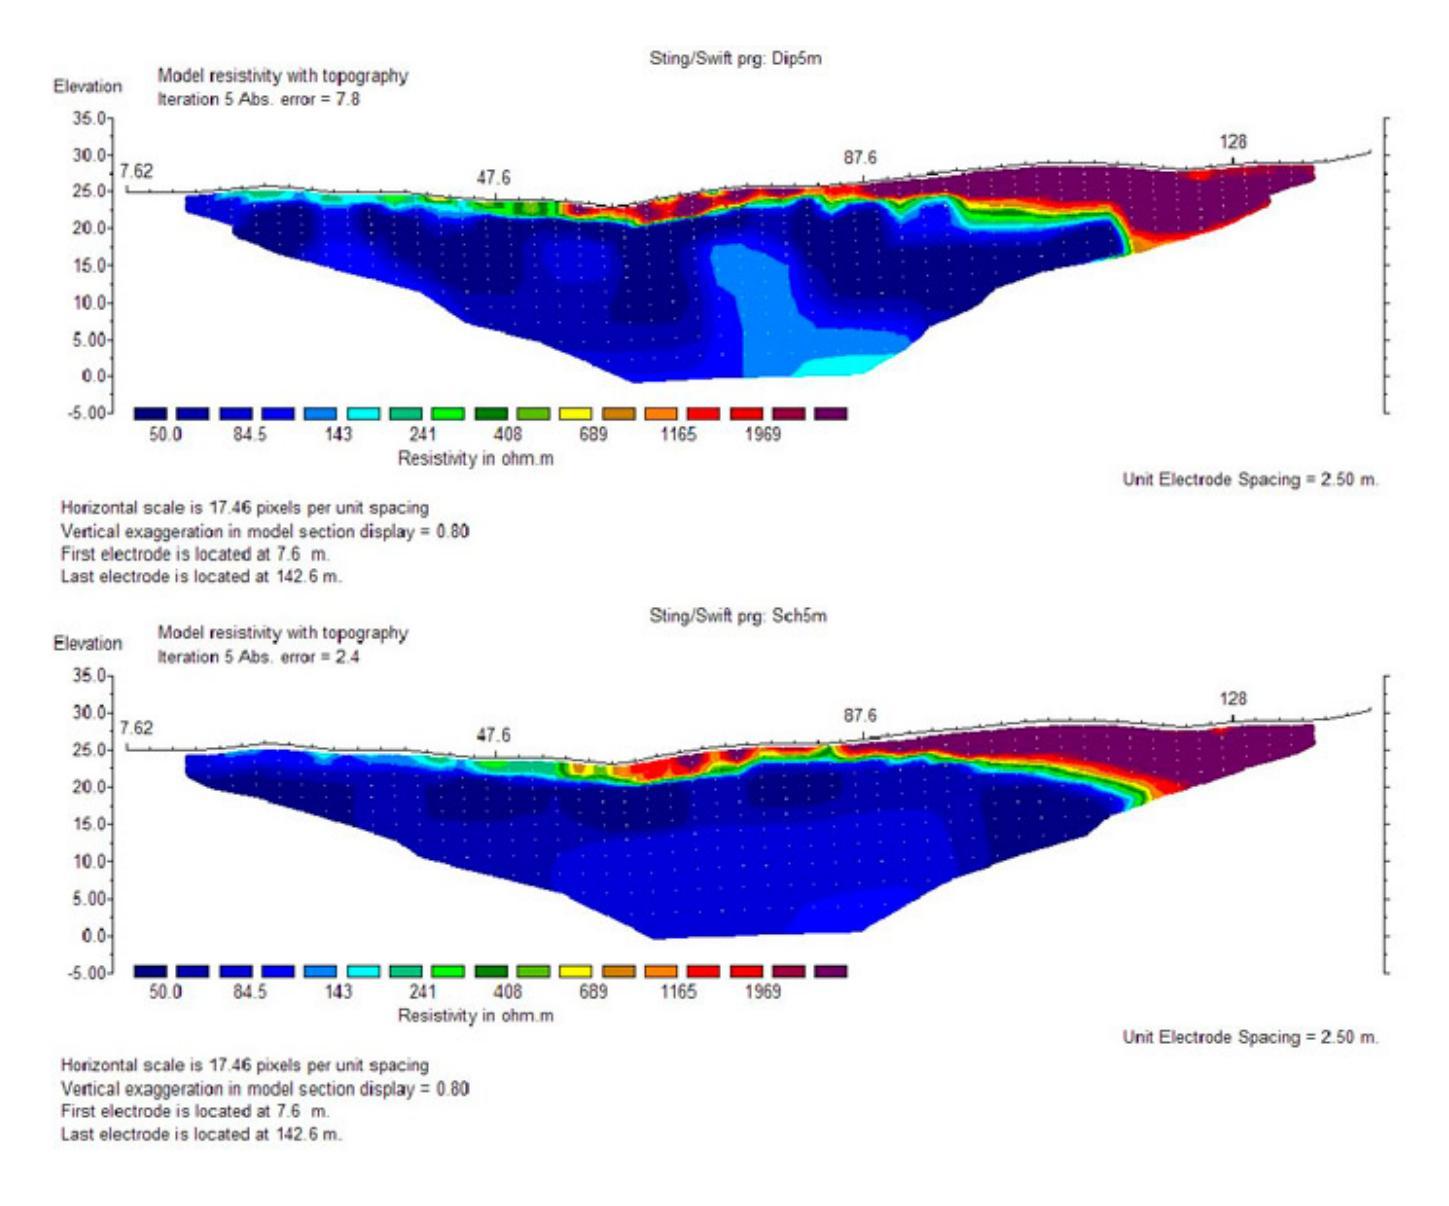
## Figure 9-48. The the inverse model for line 2 (north to south, from left to right of the profiles above) in which the true resistivity values of the subsurface tested were represented. (All distances in meters).

Figure 9-48 contains the Dipole-Dipole method (top image) and Schlumberger method (bottom image) resistivity test result for line 2. The north-south profile (line 2) in Figure 9-48 was adjusted for topography by using Global Positioning System (GPS) technology. In general, all three profiles showed a clay layer with resistivity values between 10 and 150 Wm. The clay was fairly homogeneous throughout the first 20 m to 30 m below the sand layer. Perched groundwater or saturated sand and clay were found at the contact between the two distinct permeability layers (sand overlying clay) as indicated by the high resistivity values found toward the south end of the profile. In the instance when the underlying soil became saturated, the perched groundwater elevation became, by definition, the water table elevation. The survey profile for line 1 was similar to line 2 and indicated that the clay layer was relatively homogeneous.

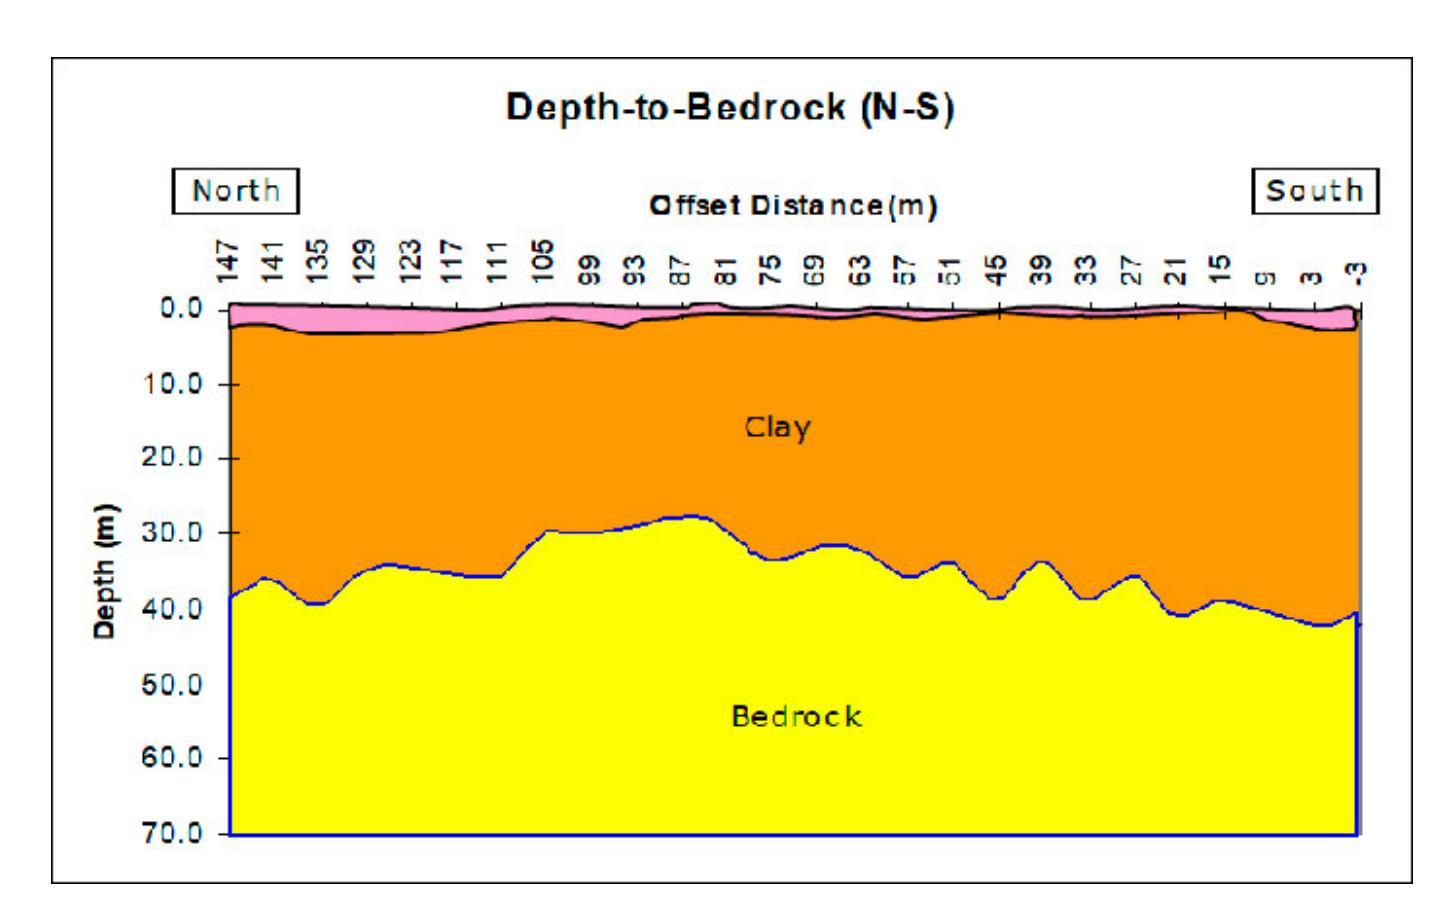
# Figure 9-49. North-South lithostratigraphy and depth-to-bedrock graph based on refraction and reflection techniques (north to south).

The goal of the seismic survey was to determine the approximate depth-to-bedrock. The data obtained to construct the site's depth-to-bedrock profiles were mined by using refraction and reflection. Basically, three soil layers were found: A thin sand layer, a thick clay layer, and bedrock. Figure 9-49 shows the north-south lithostratigraphy and depth-to-bedrock graph based on refraction and reflection techniques (north to south). The sand layer was delineated in pink. The west-wast lithostratigraphy was similar and showed bedrock at approximately 30 m of depth.

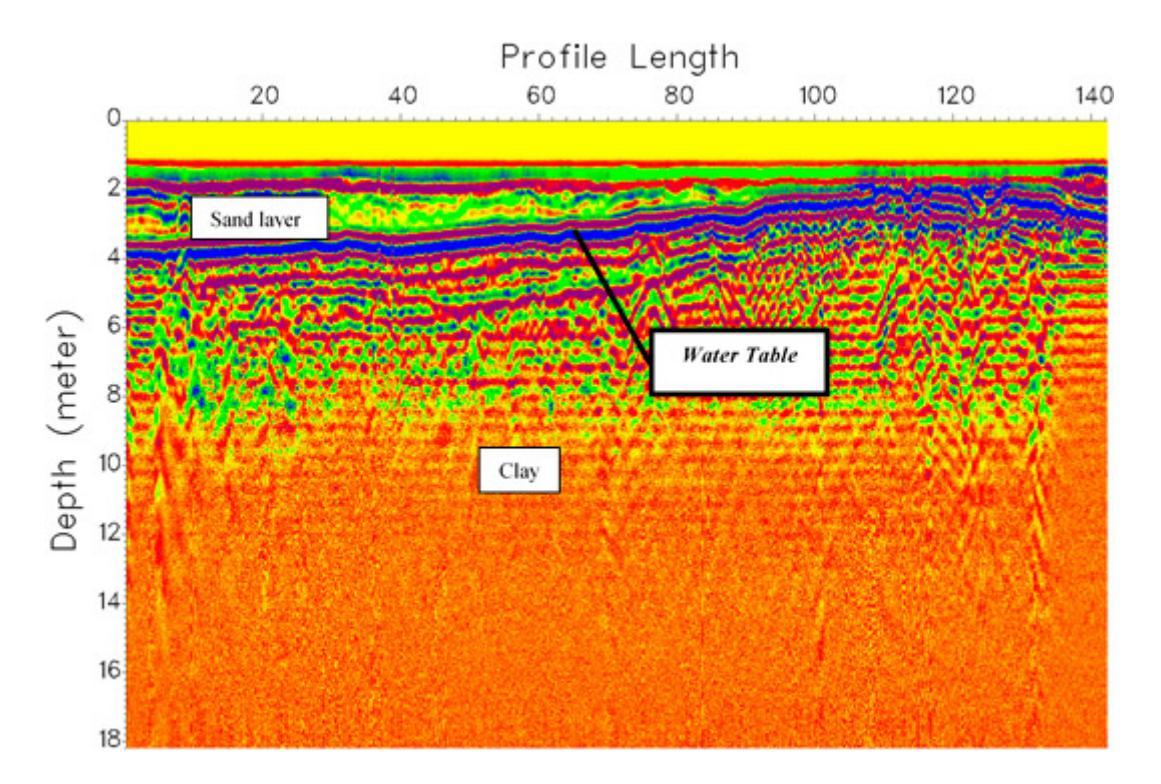
# Figure 9-50. GPR test result. The profile run from the north end of the proposed area (left corner, at 0 m) to the south end (right corner, at 140 m).

The GPR survey (see Figure 9-50) showed a layer of sand of about 2 m thick present on the north side of the site; it gradually decreased its thickness at a rate of about 2 cm/m toward the south. At about 100 m from the benchmark, the thickness of the sand layer was just a few inches. A clay layer was under the sand and the GPR could not penetrate it. It was expected that groundwater flowed at the interface between the sand and the saturated clay layers. No surface topography adjustment was made as the surface had relatively minor changes in elevation (zero-slope, man-made dirt road).
