## 9.3 OIP-Green Probe Delineates Extent of Coal Tar NAPL at a Former Gas Manufacturing Plant in Kansas

Wesley McCall, P.G. Geoprobe Systems<sup>®</sup>, Salina, KS mccallw@geoprobe.com Jonathan L. Stephenson, I.G. Environ. Spec. KDHE BER Orphan Sites Unit, Topeka, KS jonathan.stephenson@ks.gov

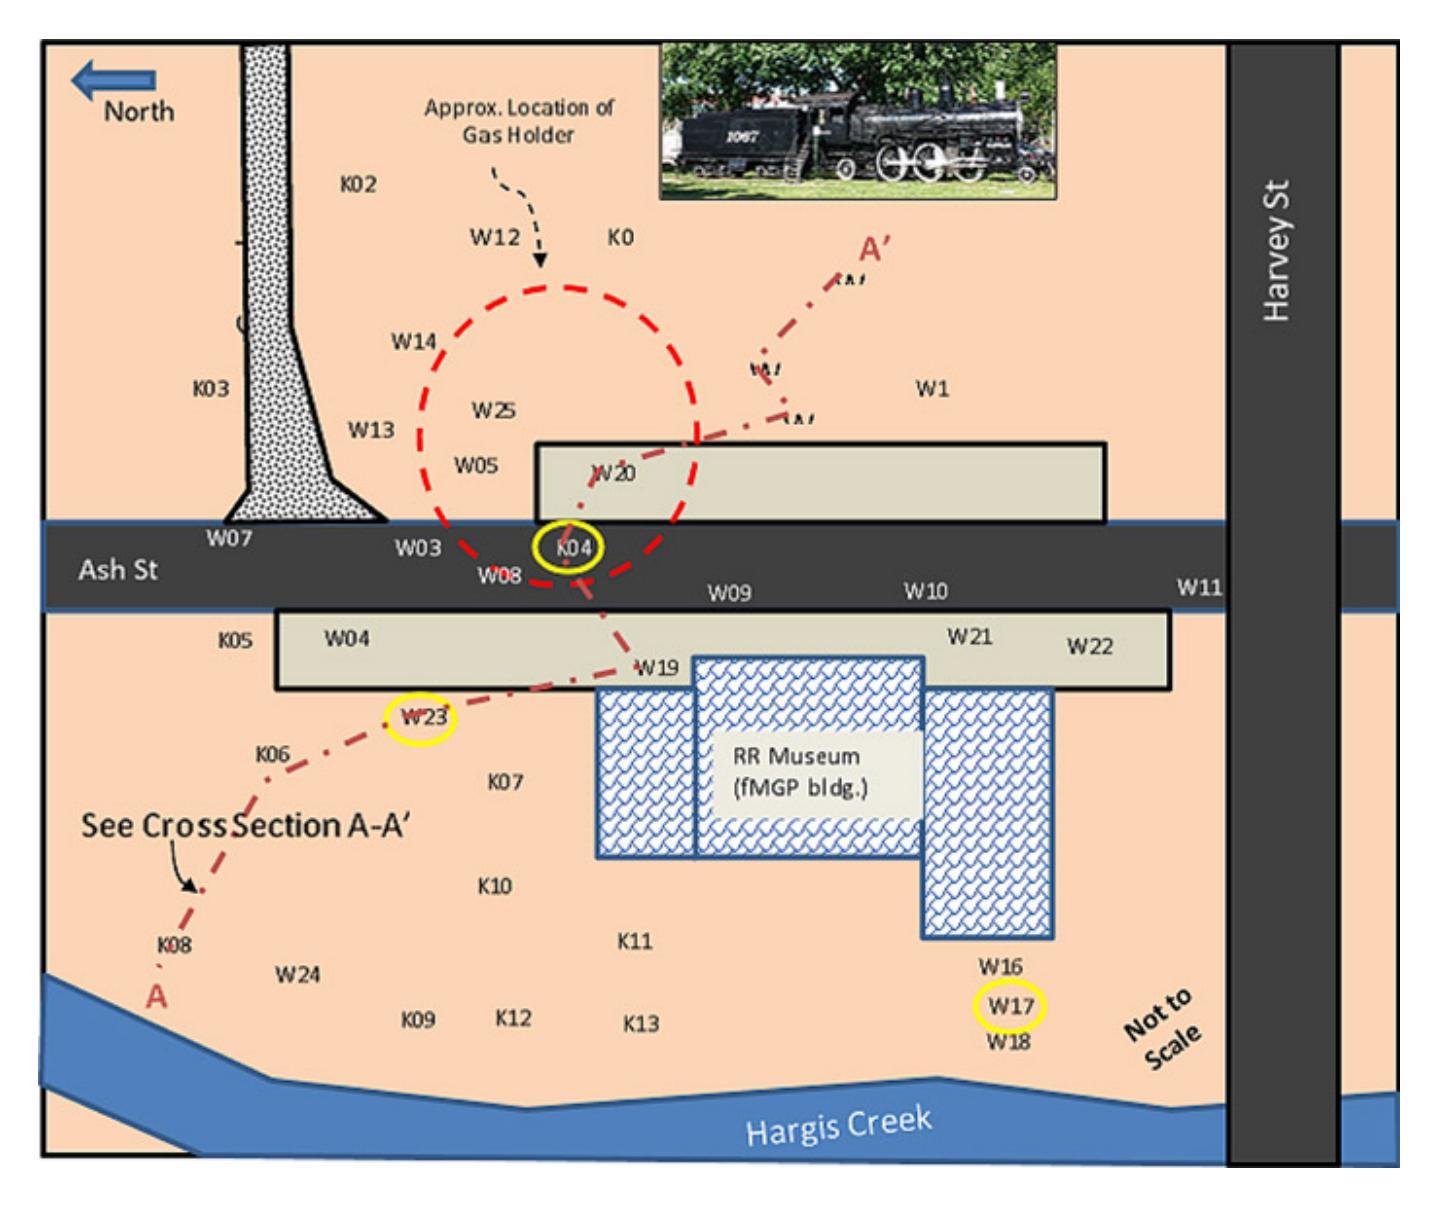
### Figure 9-9. Site sketch map with log and cross section locations.

Log locations were selected based on previous site data and to fill data gaps (see Figure 9-9). Thirty-four OIP-G logs were obtained with depths between about 25 ft to 30 ft.

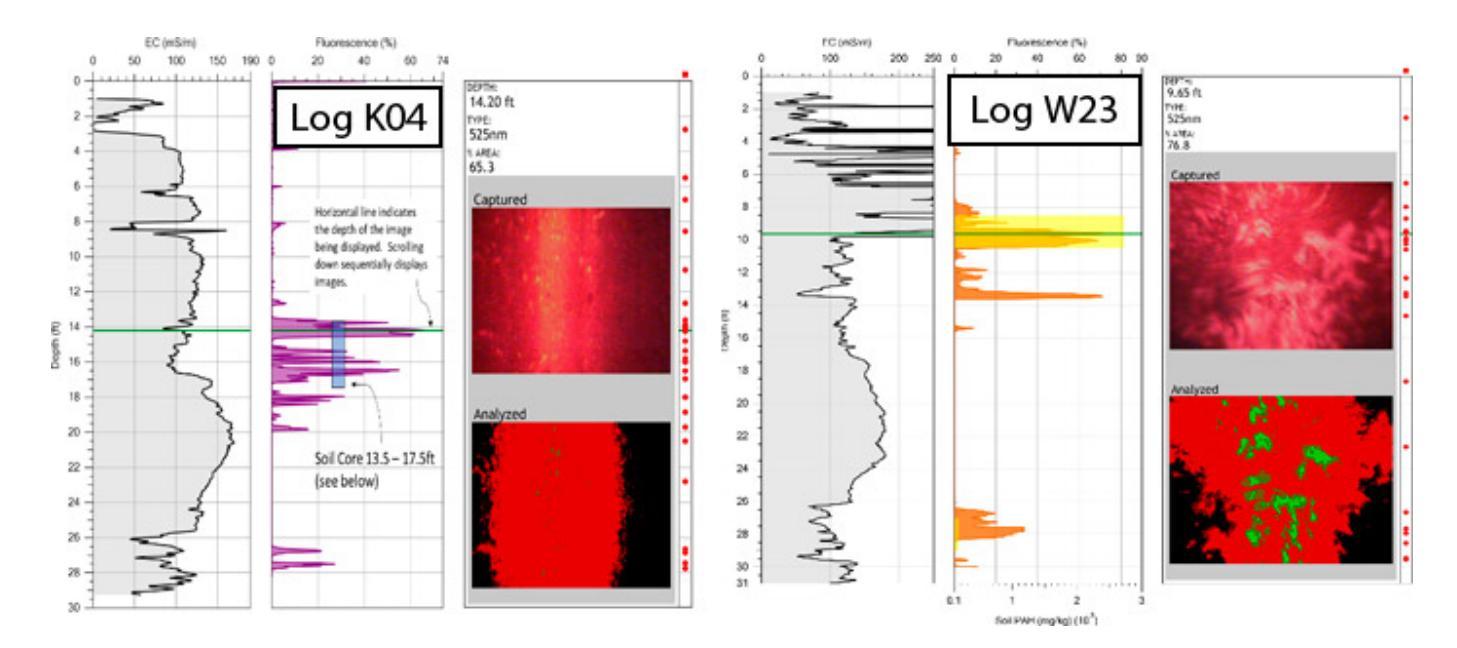
Log K04 showed high fluorescence levels between about 13 ft to 20 ft below ground surface (see Figure 9-10). A soil core sample was collected from 13.5 ft to 17.5 ft at this location. Coal tar DNAPL was poured out of the soil liner into a 4-oz. jar before subsampling the soil for analysis. The soil sample analysis revealed a total PAH load of 6,016,000  $\mu$ g/kg. Log W23 (see Figure 9-10) showed high EC spikes in the upper 10 ft indicating the presence of buried metal. Log W23 also showed several zones of elevated fluorescence. A soil core was collected from 9 ft- to 11ft interval and submitted for analysis. The results revealed a total PAH load of 2,724,000  $\mu$ g/kg.

Many of the EC logs displayed lower EC near the middle of the formation (for example, about 14 ft to 17 ft in log K04) and then again just above the shale bedrock (for example, about 26 ft to 28 ft in log K04). Samples collected across these low EC intervals typically had a higher sand and gravel content and were therefore more permeable. High fluorescence readings were often observed in the lower EC zones, especially just above the shale bedrock. A cross section of logs (see Figure 9-11) reveals a high EC zone near the middle of the formation. Samples from these zones revealed the soils to be a low permeability, silty clays. Gray shading in Figure 9-11 also shows total PAH results from soil samples collected at those approximate depths. Orange shading in Figure 9-10 represents percent fluorescence from 0% to 90%. The cross section also shows that the coal tar NAPL typically lies above and below the low permeability zone, as indicated by elevated fluorescence levels. (McCall, Christy, Pipp, Jaster, Bean, et al. 2018). Confirmation sampling verified that fluorescence observed by the OIP-G successfully identified coal tar contamination at multiple locations across the area investigated. Cross sections with the logs were able to provide a clear guide to the distribution of coal tar NAPLs.

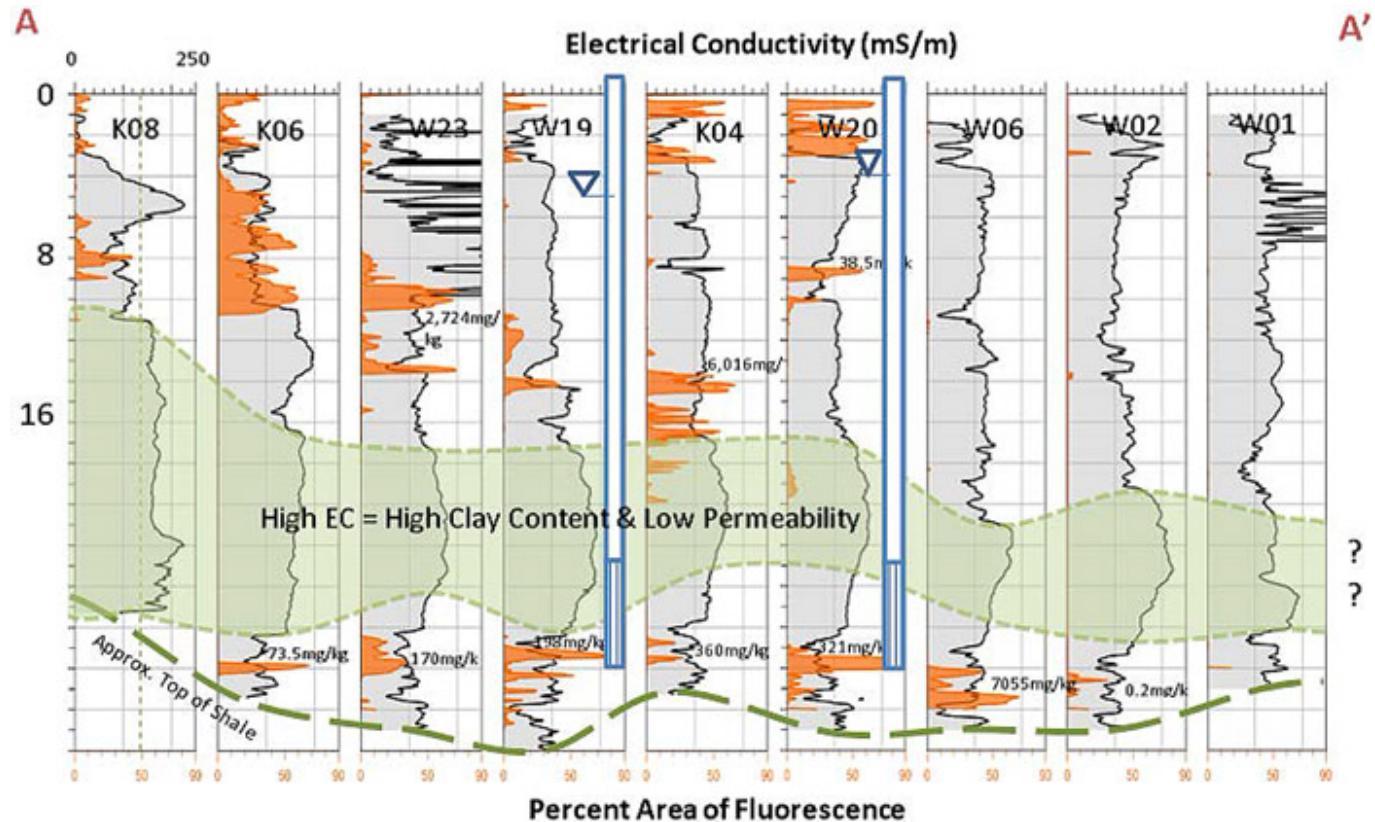
### Figure 9-11. Cross section A - A' (see Figure 9-9 for location; not to scale).

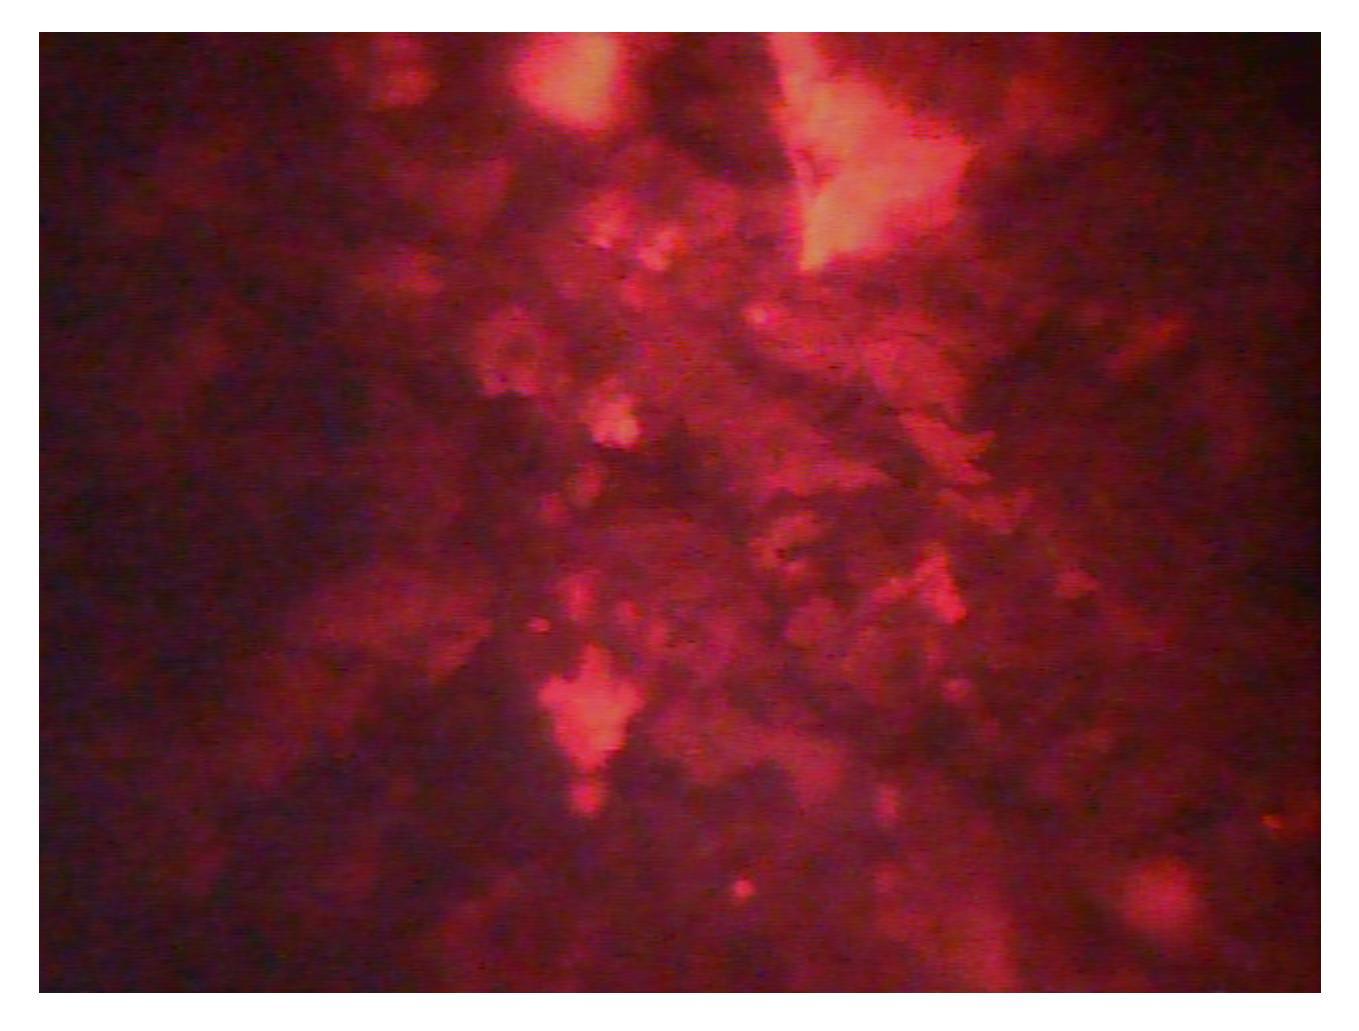
### Figure 9-12. Red-orange fluorescence of calcareous minerals observed under green (525 nm) source light.

The biggest disadvantage of this tool is that it can produce false positives in fluorescence if there are calcareous materials present in the path of the probe. At this site, elevated fluorescence (about 40%) in the red-orange wavelength typical of coal tar was observed at locations W17 and W18 (see Figure 9-12). Soil coring results showed no coal tar contamination at these locations but light-colored particles were observed in the soil. A test with dilute hydrochloric acid produced effervescence, indicating calcite/limestone. Calcite is known to fluoresce. It is thought that limestone-based sand and gravel may have been used as fill material along the stream bank at this location. Similar fluorescence was observed from small caliche nodules present in the soil. Geoprobe is attempting to reduce the false positive problem by using an infrared LED to differentiate between dark-colored contaminants and light-colored minerals. In the meantime, targeted soil sampling may be required to verify the cause of fluorescence.
